# Pre-Demolition Hazardous Materials Survey

Former YMCA Building  
111 North Madison Avenue  
Bay City, Michigan 48708

**PROJECT #** 11146s2-2-194

**DATE** November 9, 2017

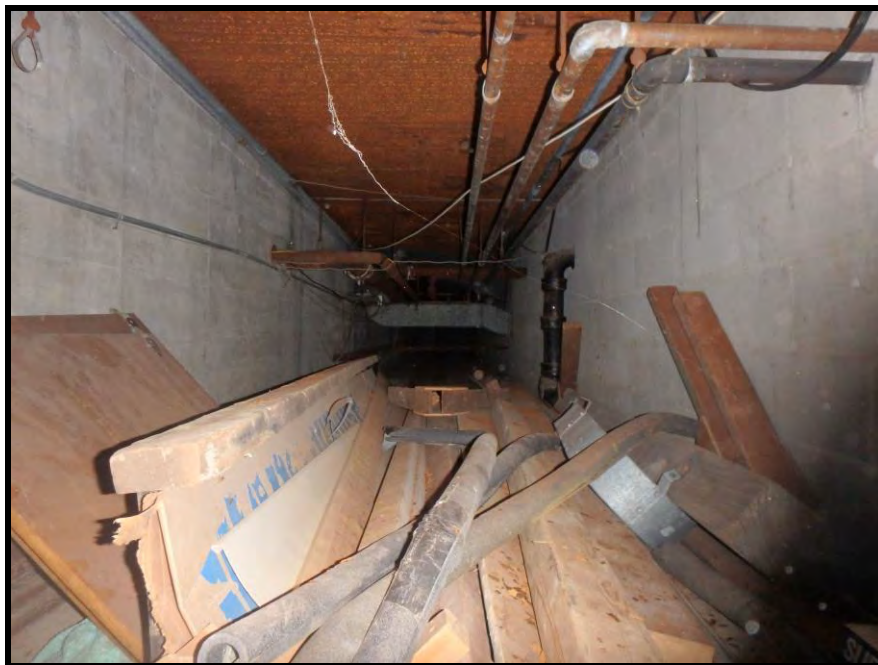
**INTERIOR VIEW OF TUNNEL  
DEBRIS**

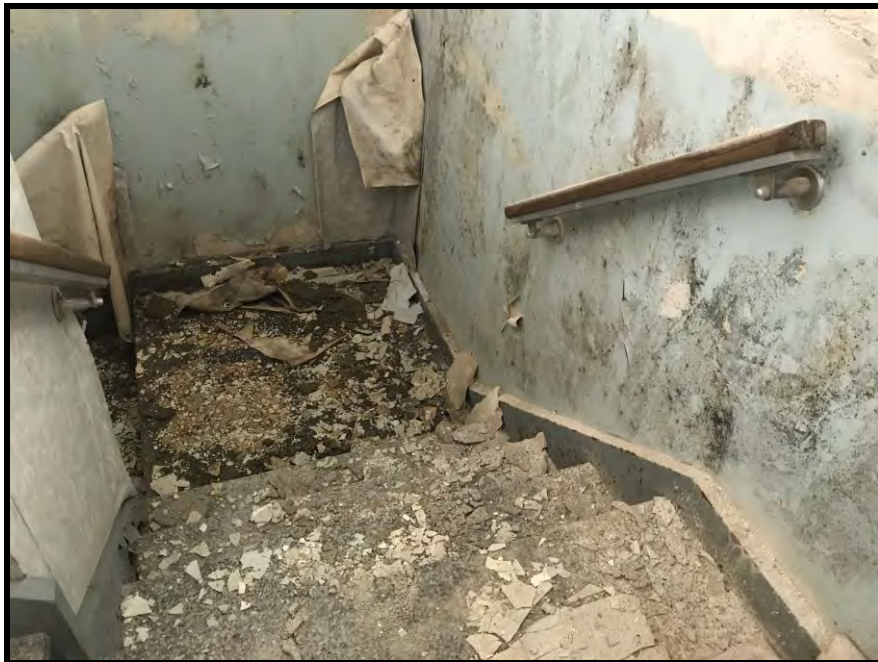
**INTERIOR VIEW OF STAIRWAY  
AND MOISTURE INTRUSION**

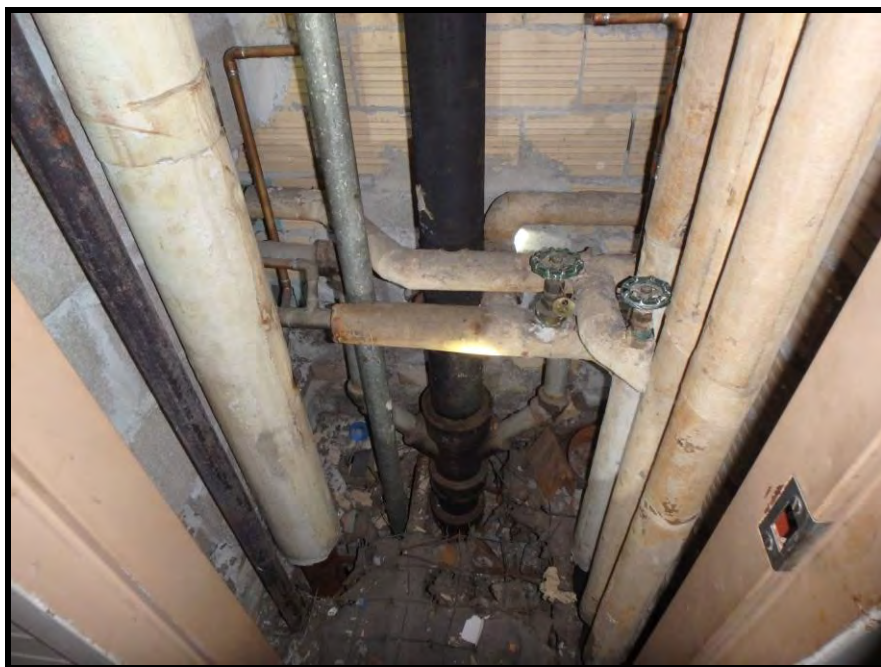
**REPRESENTATIVE VIEW OF PIPE CHASE  
MUD FITTINGS (HA-2) AND PIPE WRAP (HA-3)**

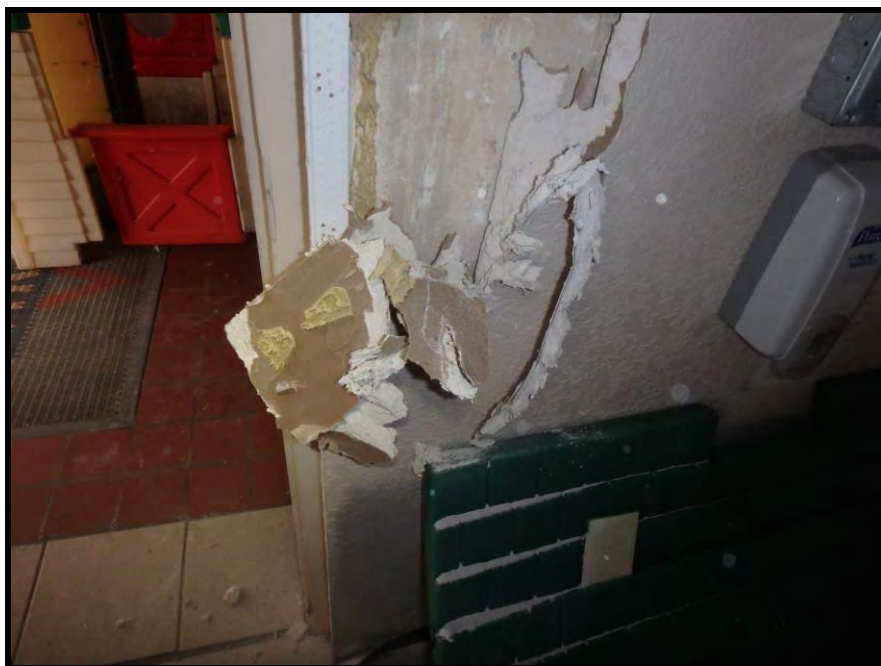
**INTERIOR VIEW  
DRYWALL ADHESIVE (HA-50)**

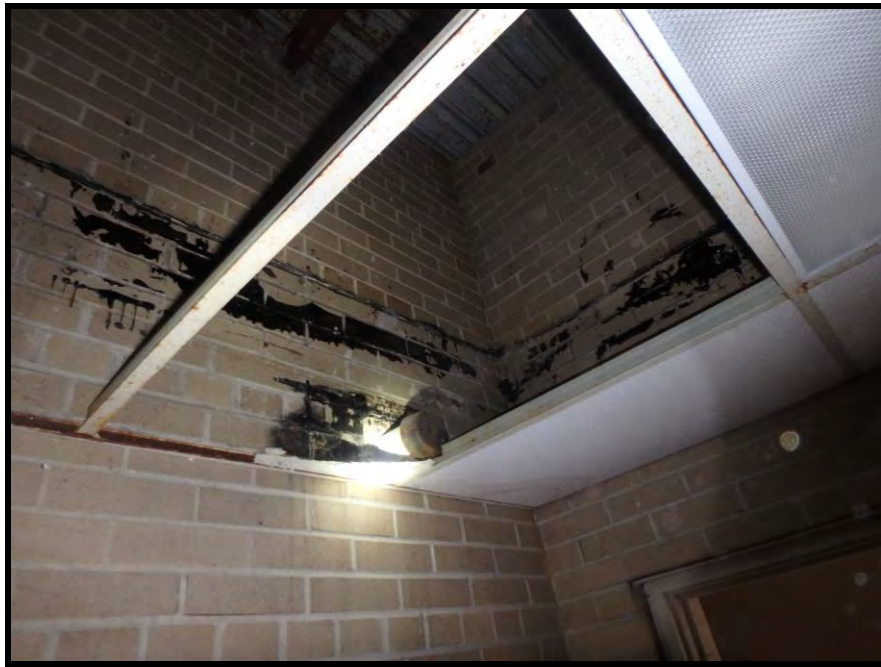
**INTERIOR VIEW OF 1<sup>ST</sup> FLOOR, HALLWAY TO POOL AREA  
FORMER ROOF LINE (HA-61)**

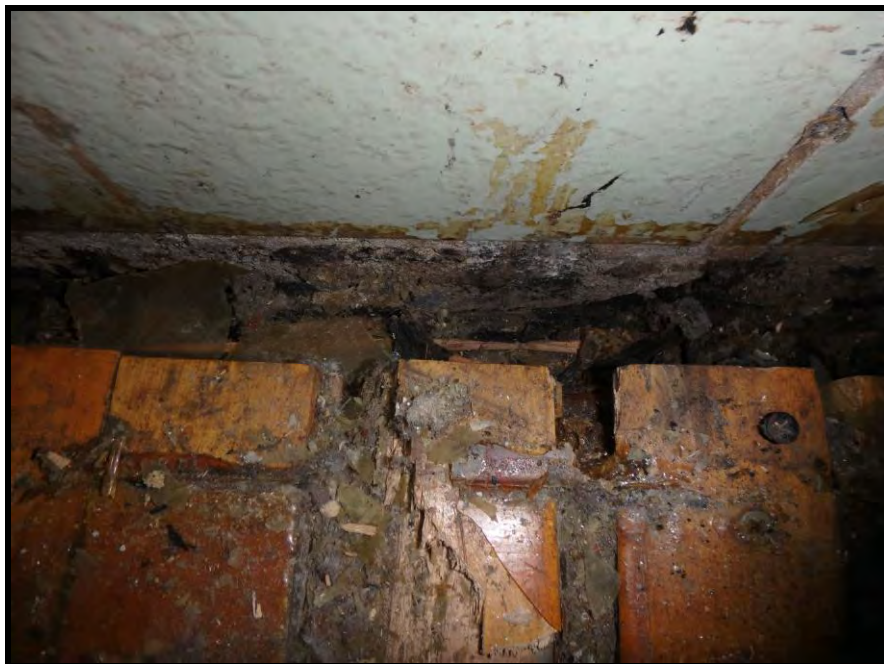
**INTERIOR VIEW OF GYMNASIUM  
FLOOR BARRIER PAPER (HA-62)**

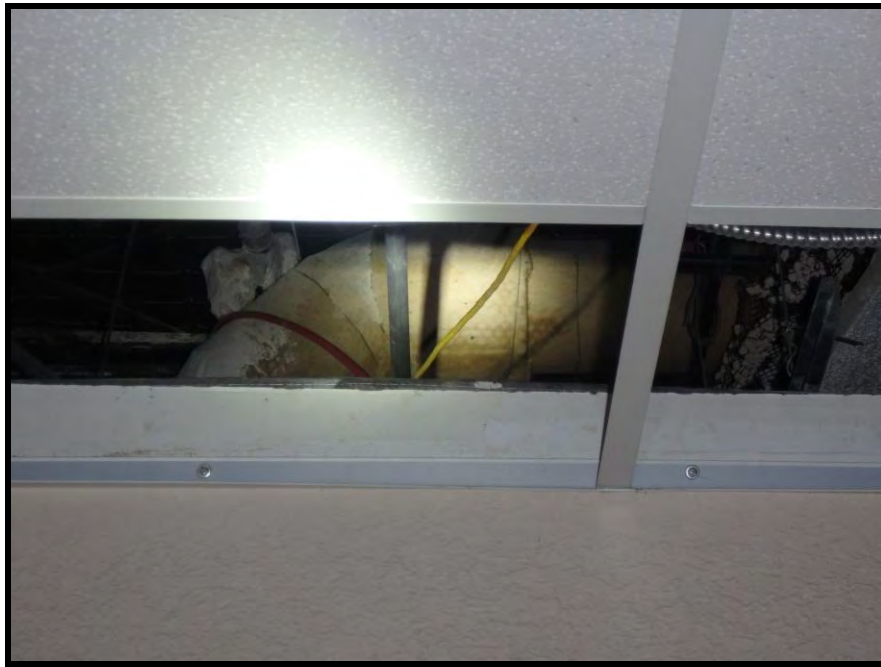
**INTERIOR VIEW OF 1<sup>ST</sup> FLOOR ABOVE CEILING  
SUSPECT TRANSITE PIPE (HA-84)**

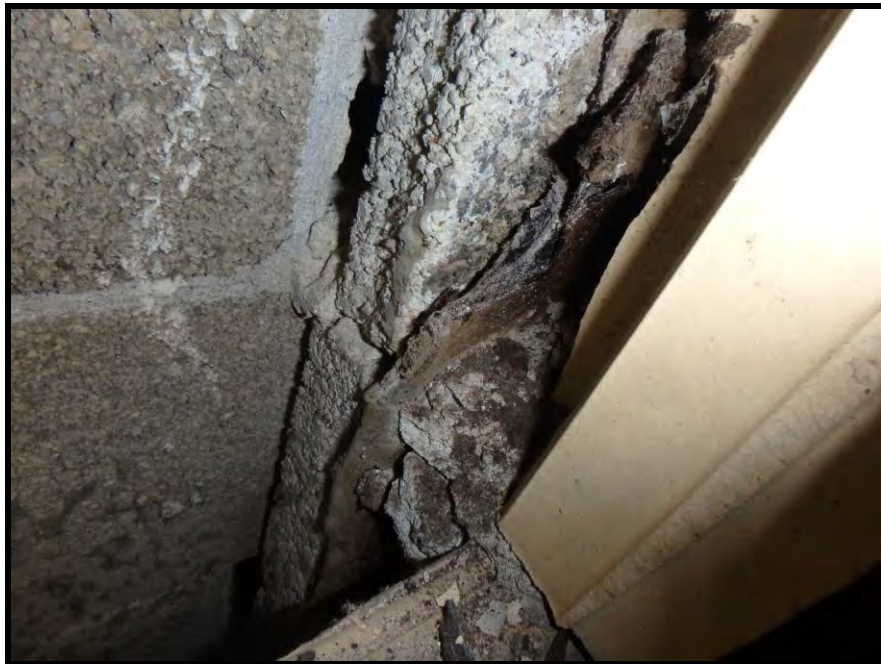
**INTERIOR VIEW OF POOL AREA  
BLACK PAPER WITHIN PERIMETER WALL (HA-87)**

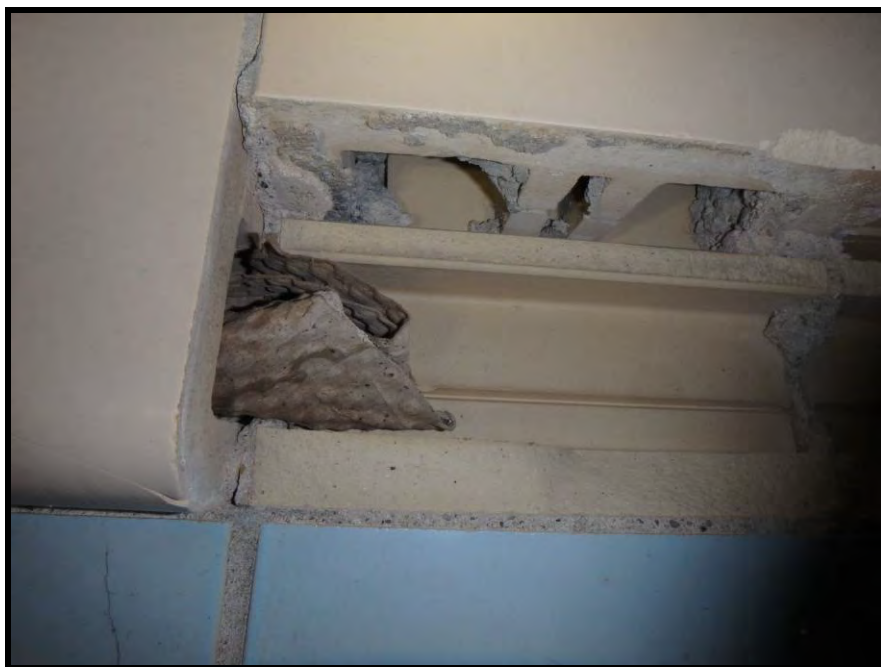
**INTERIOR VIEW OF POOL AREA  
BROWN PAPER WITHIN GLAZED WALLING (HA-88)**

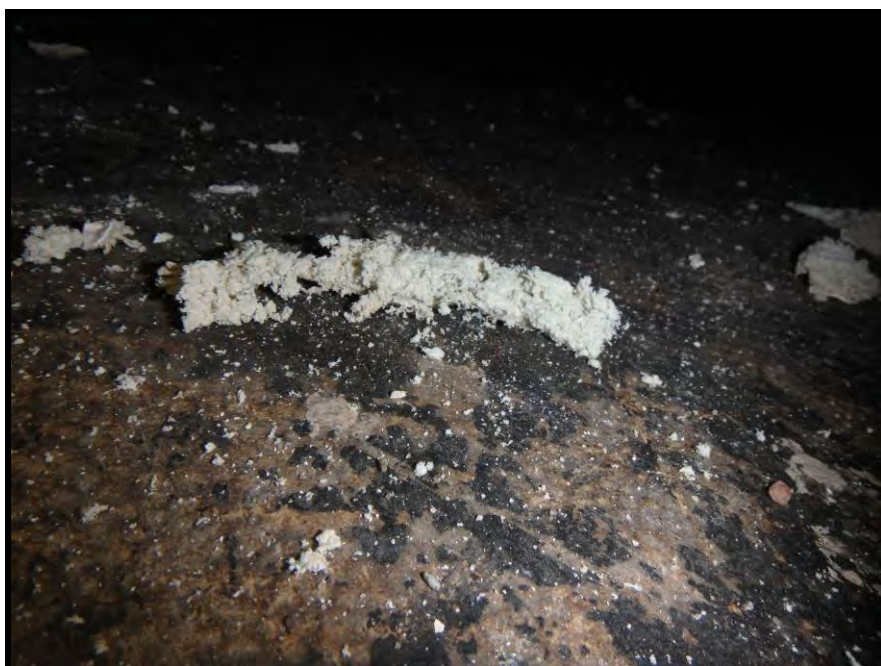
**INTERIOR VIEW OF BASEMENT  
TEXTURED CEILING MATERIAL (HA-89)**

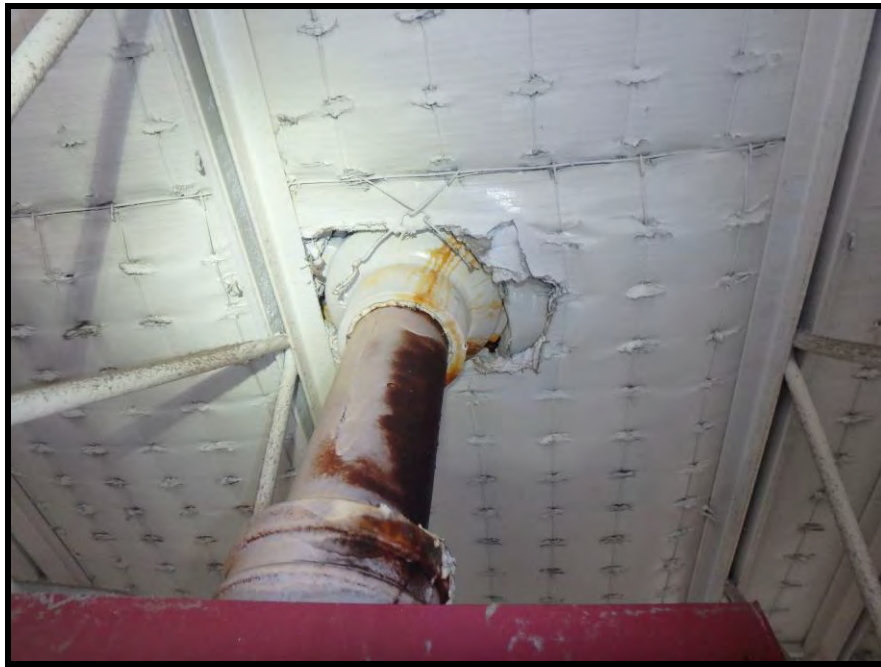
**REPRESENTATIVE VIEW OF CEILING DRAIN MATERIAL (HA-70) AND  
PAPER TYPE CEILING MATERIAL (HA-71)**

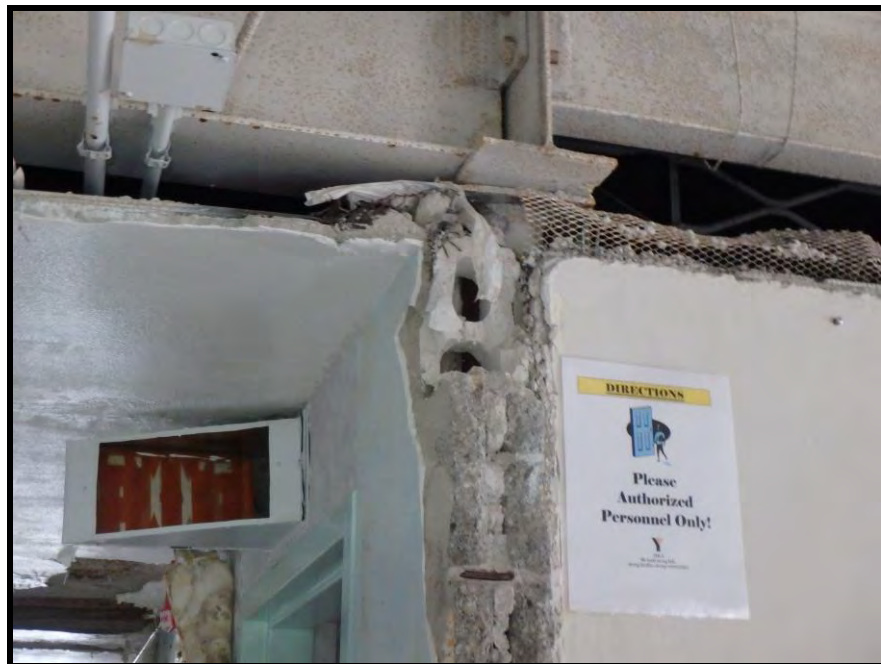
**REPRESENTATIVE VIEW OF WHITE FIRE BLOCK (HA-90)**

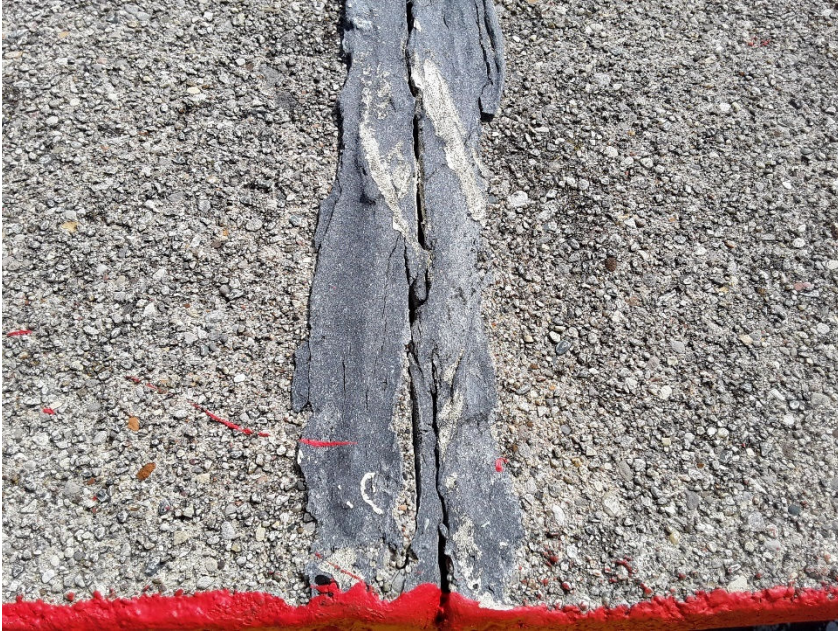
### **Photograph 27**

**View of Asbestos Containing Black Exterior  
Building Caulk  
(HA26)**

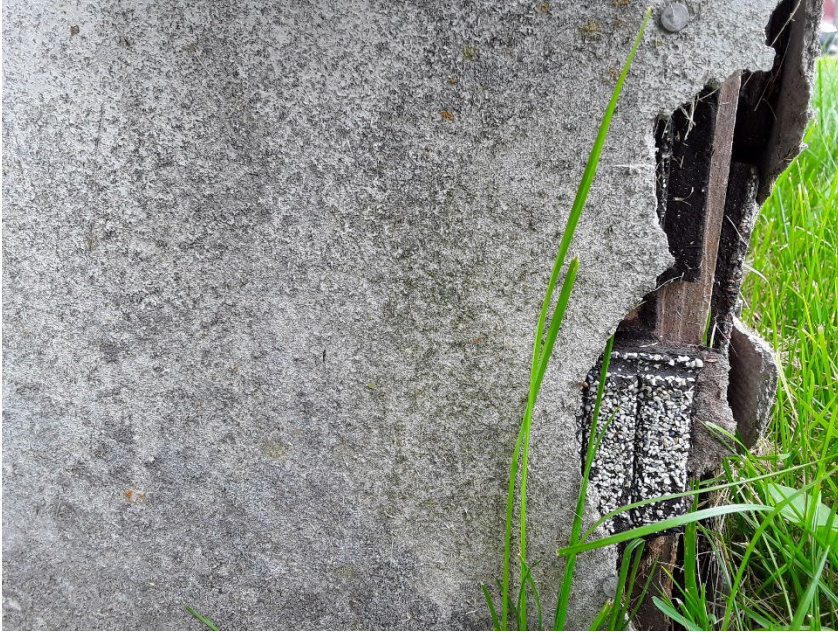
### **Photograph 9**

**View of Asbestos Containing Exterior  
Transite Skirting  
(HA8)**
