# Pre-Demolition Hazardous Materials Survey

Former YMCA Building  
111 North Madison Avenue  
Bay City, Michigan 48708

**PROJECT #** 11146s2-2-194

**DATE** November 9, 2017

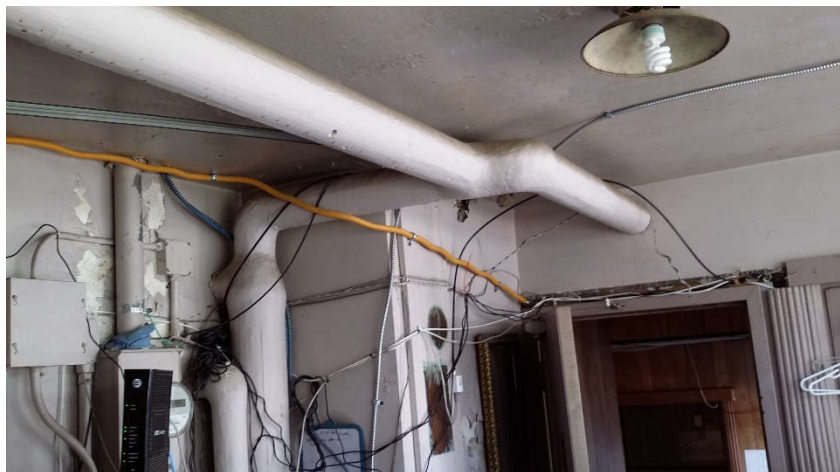
### Photograph 3

**View of Asbestos Containing Straight Pipe  
Insulation  
(HA2)**

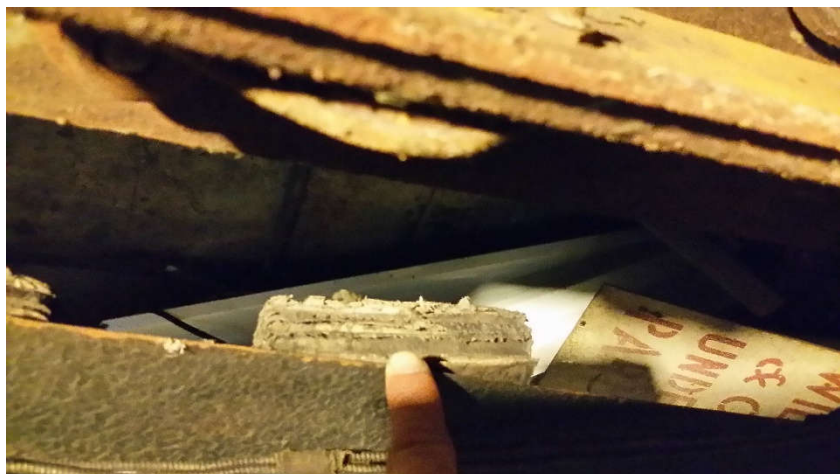
### Photograph 4

**View of Asbestos Containing Boiler  
Insulation  
(HA3)**

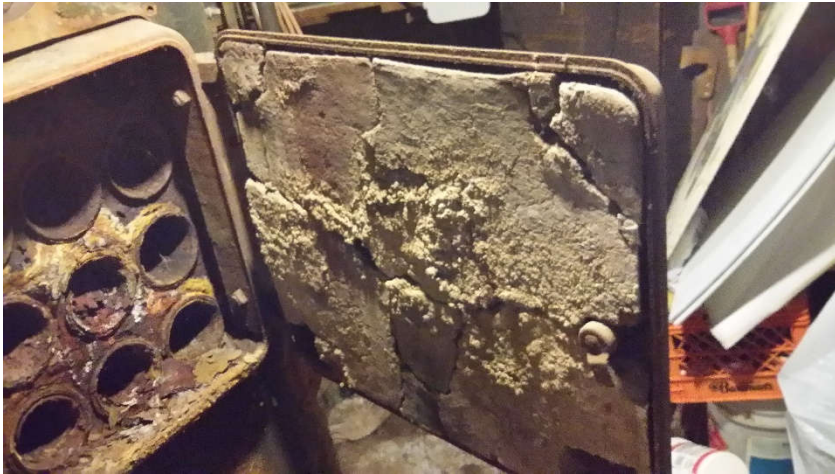
### **Photograph 5**

**View of Asbestos Containing Boiler Door  
Insulation  
(HA4)**

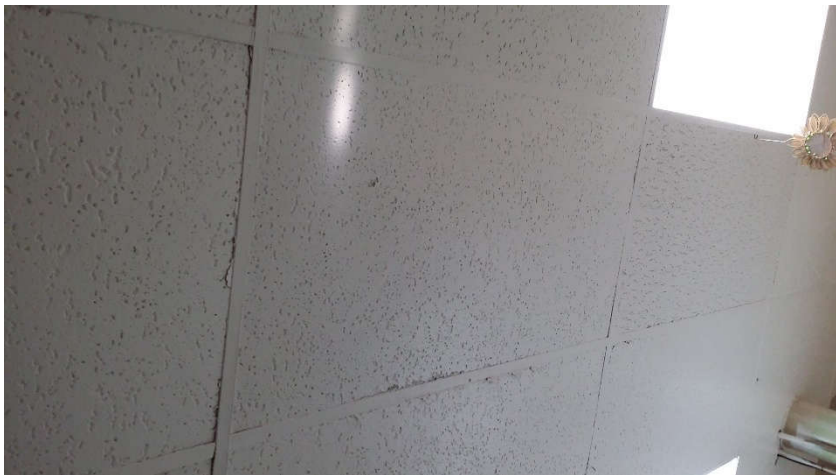
### Photograph 8

View of 2' x 4' Suspended Ceiling Tile – Long  
Gouges and Pinholes  
(HA7)

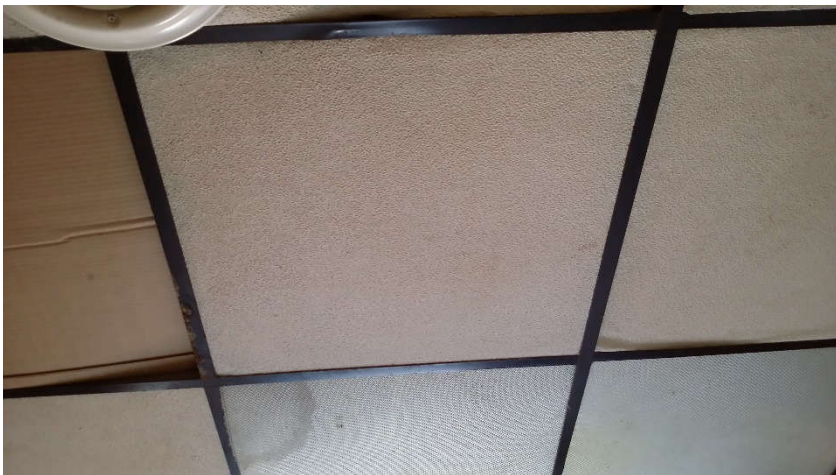
### Photograph 14

View of 2' x 2' Ceiling Tile with Pinholes and  
Long Gouges  
(HA13)

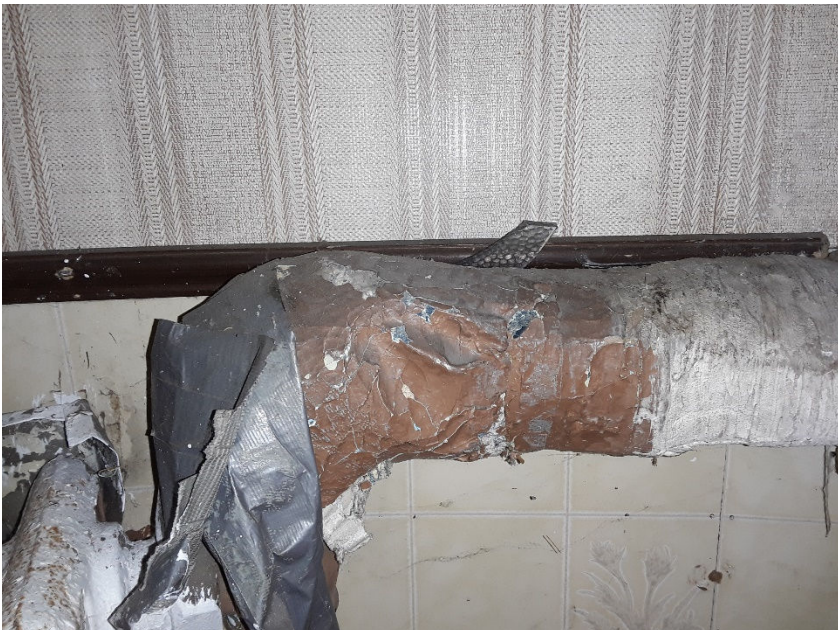
### **Photograph 2**

The laboratory results indicate the mudded fittings associated with straight pipe insulation (HA1), straight pipe insulation (HA2), boiler insulation (HA3), boiler door insulation (HA4), and flat roofing materials (HA15) contained asbestos in concentrations greater than one percent and are therefore considered ACMs. As noted in the summary table, the ACM was also assessed to be in damaged condition at the time of the inspection.

**View of Asbestos Containing Mudded  
Fittings Associated with Straight Pipe  
Insulation  
(HA1)**

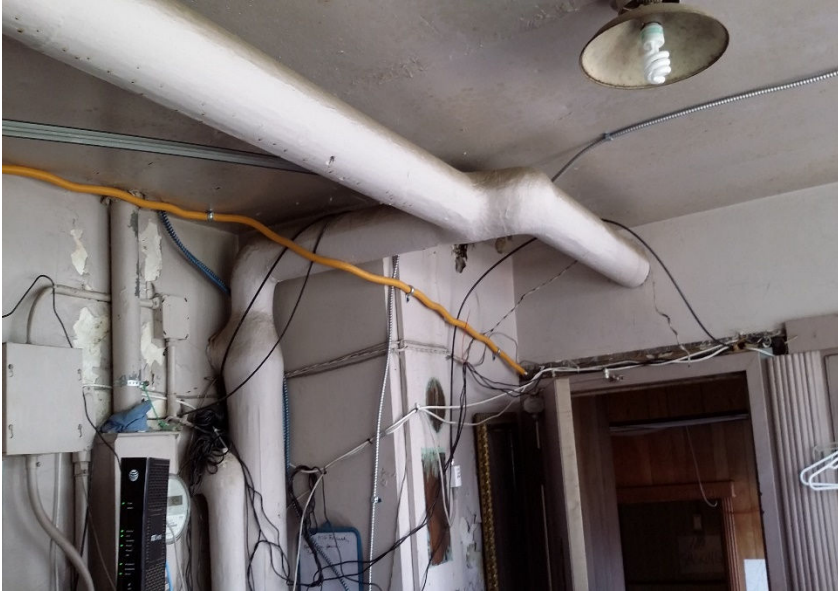
### Photograph 3

**View of Asbestos Containing Straight Pipe  
Insulation  
(HA2)**

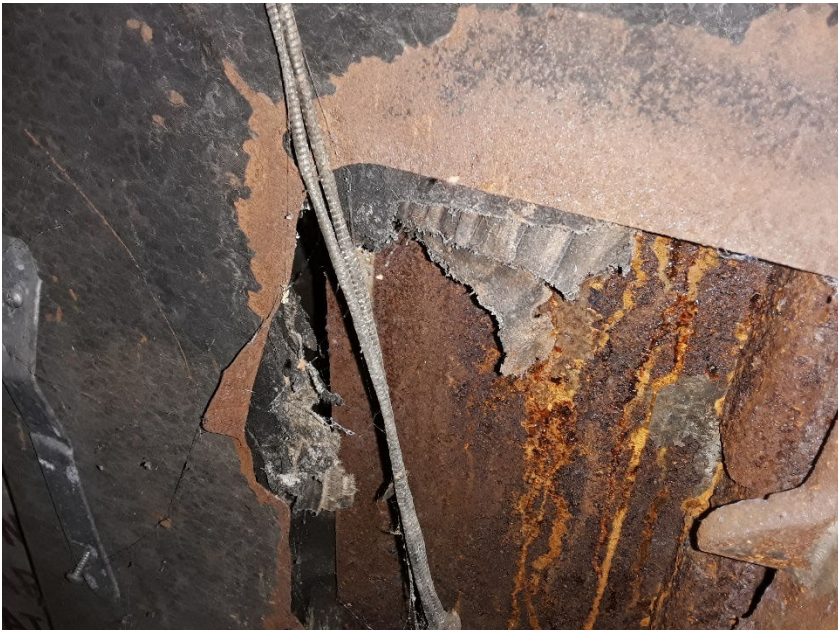
### Photograph 4

**View of Asbestos Containing Boiler  
Insulation  
(HA3)**

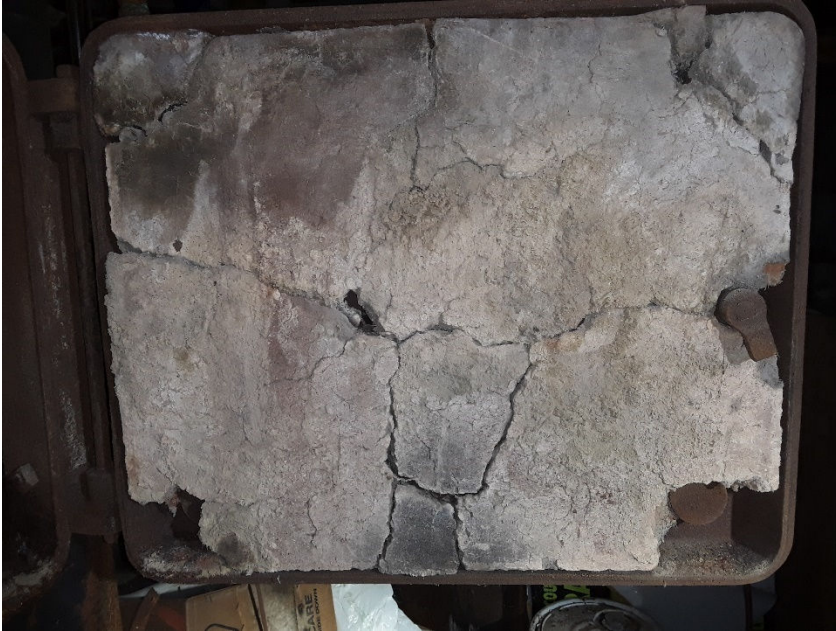
### Photograph 5

**View of Asbestos Containing Boiler Door  
Insulation  
(HA4)**

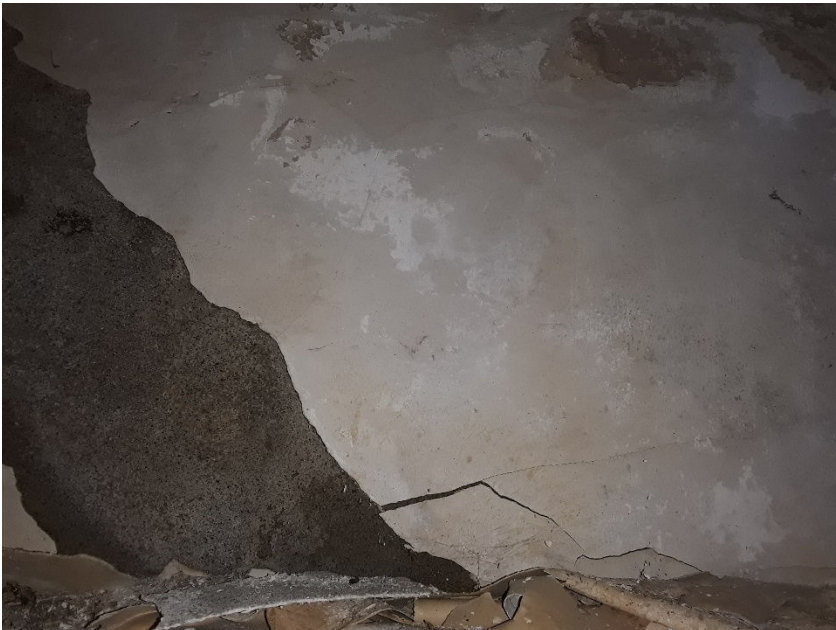
### Photograph 6

**View of Wall and Ceiling Plaster  
(HA5)**

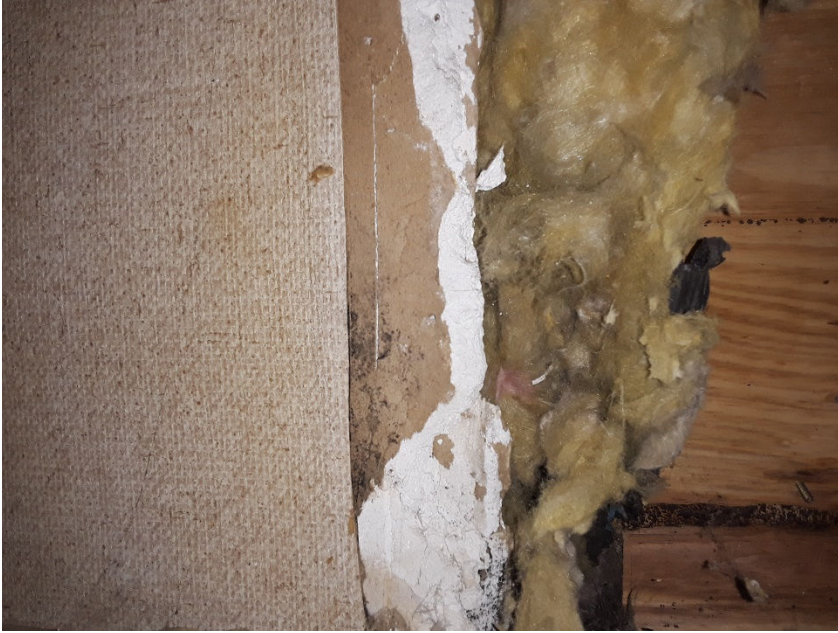
### **Photograph 7**

View of Unfinished Drywall Panels  
(HA6)

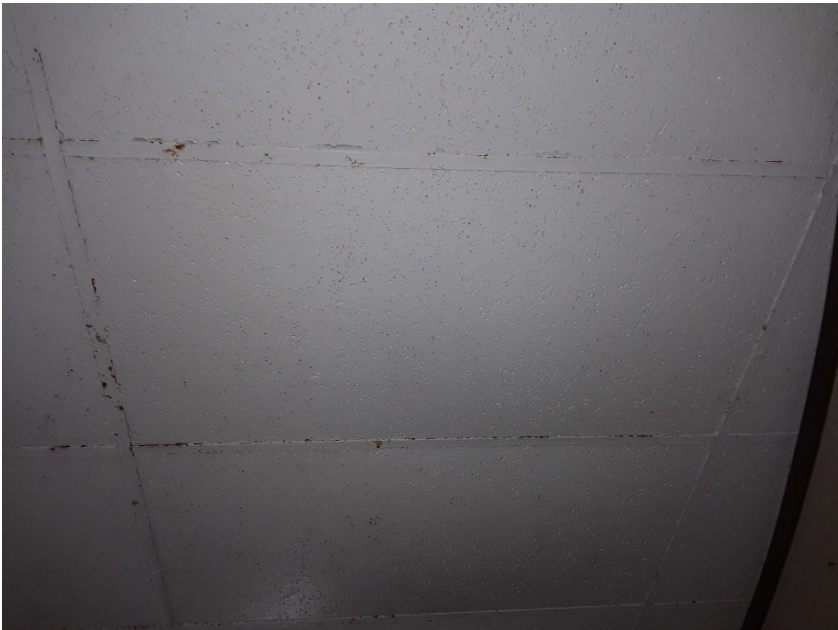
### **Photograph 8**

View of 2' x 4' Suspended Ceiling Tile with  
Long Gouges and Pinholes  
(HA7)

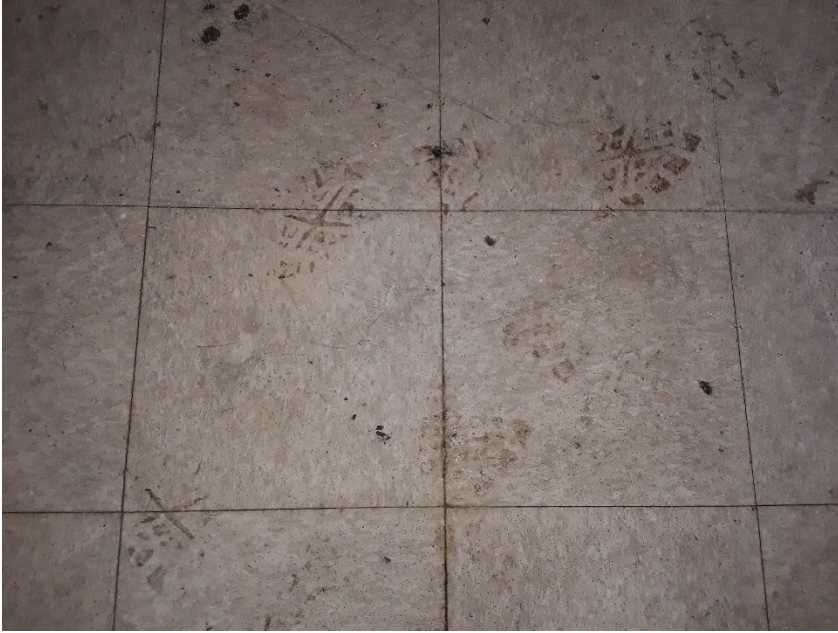
### Photograph 9

View of 12" x 12" Tan Mottled Floor Tile and  
Mastic  
(HA8)

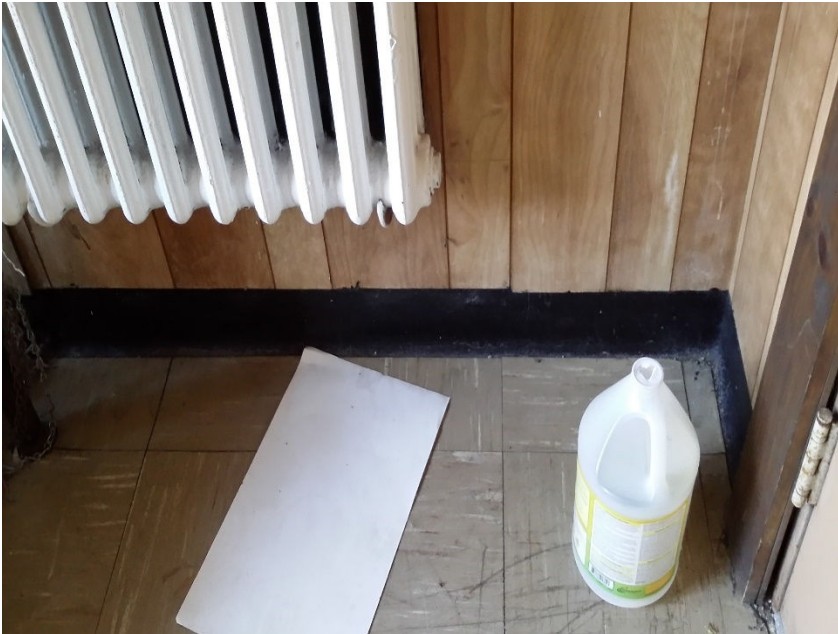
### Photograph 10

View of Brown Cove Base and Adhesive  
(HA9)

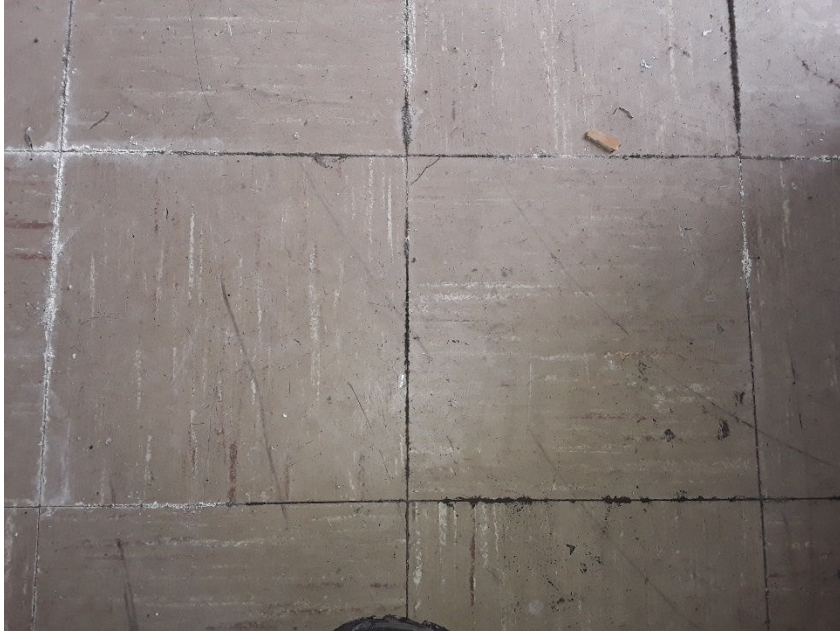
### **Photograph 11**

View of 12" x 12" Grey Mottled Floor Tile and  
Mastic  
(HA10)

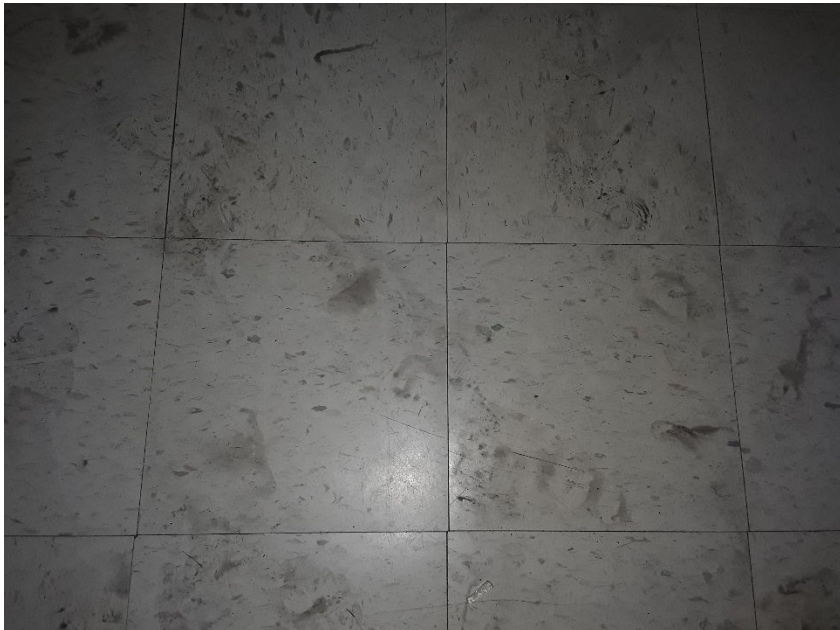
### **Photograph 12**

View of 12" x 12" White with Red and Blue  
Specks Floor Tile and Mastic  
(HA11)

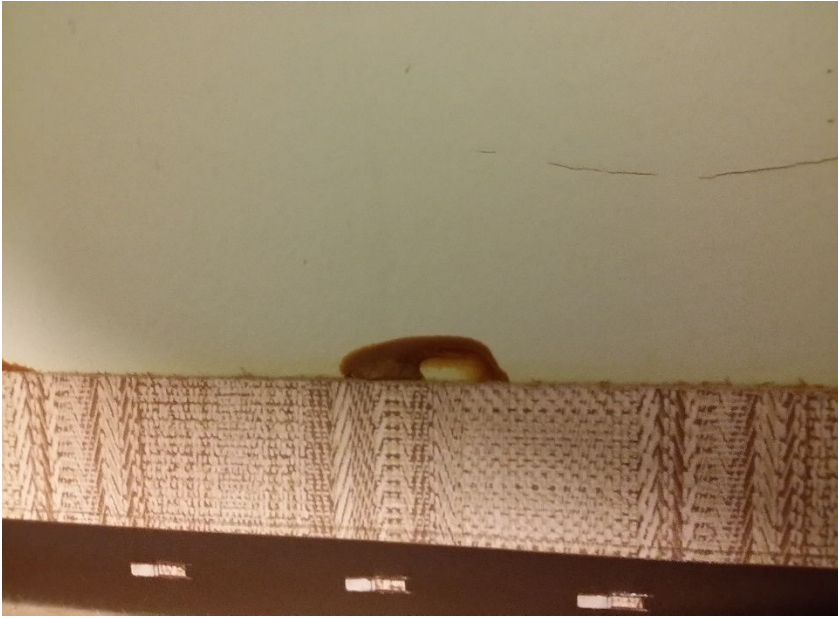
### Photograph 13

View of Wall Board Adhesive  
(HA12)

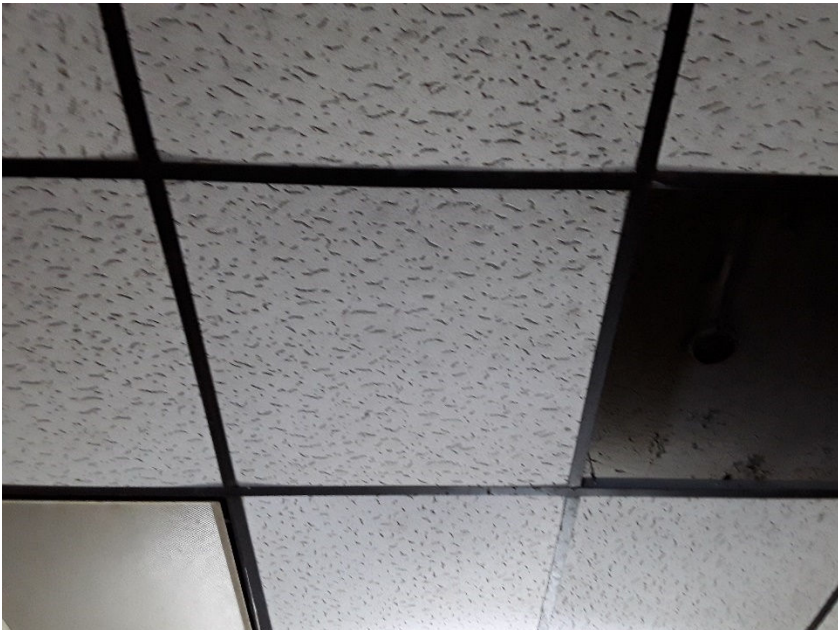
### Photograph 14

View of 2' x 2' Ceiling Tile with Pinholes and  
Log Gouges  
(HA13)

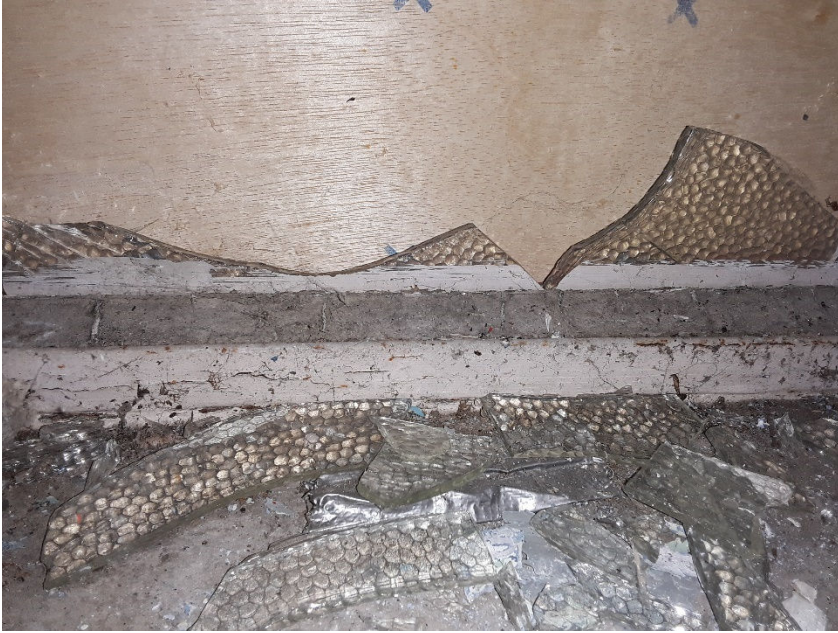
### Photograph 15

View of Window Glazing  
(HA14)

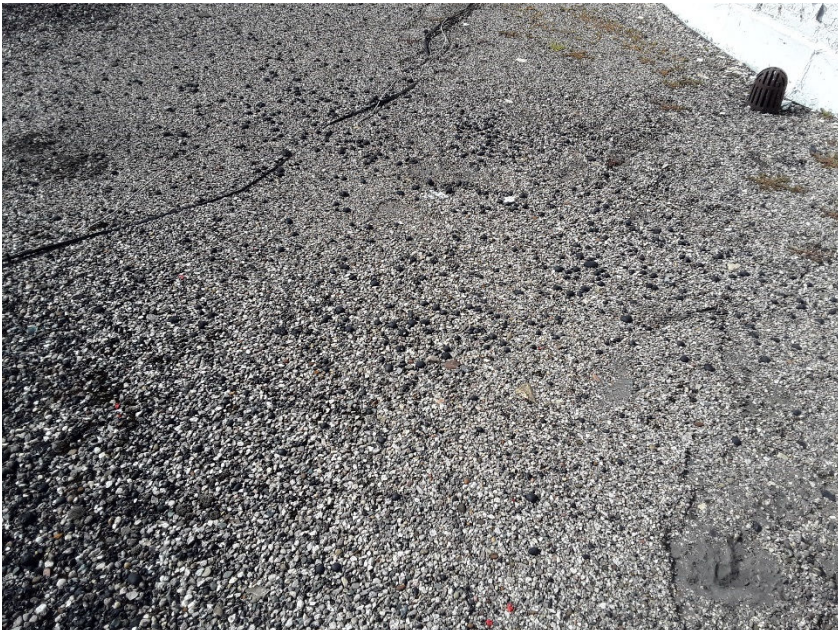
### Photograph 16

View of Asbestos Containing Flat Roofing  
Materials  
(HA15)

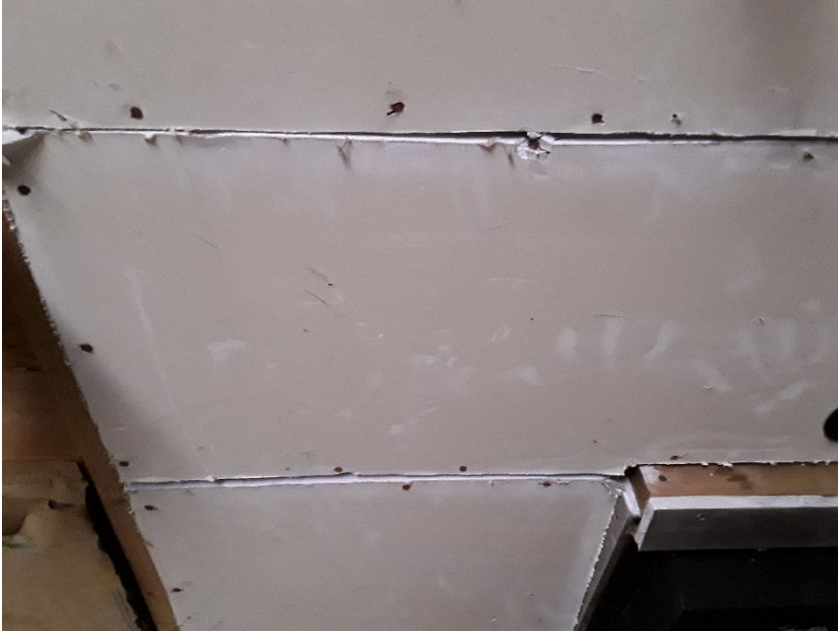
### Photograph 17

View of Drywall Panels  
(HA16)

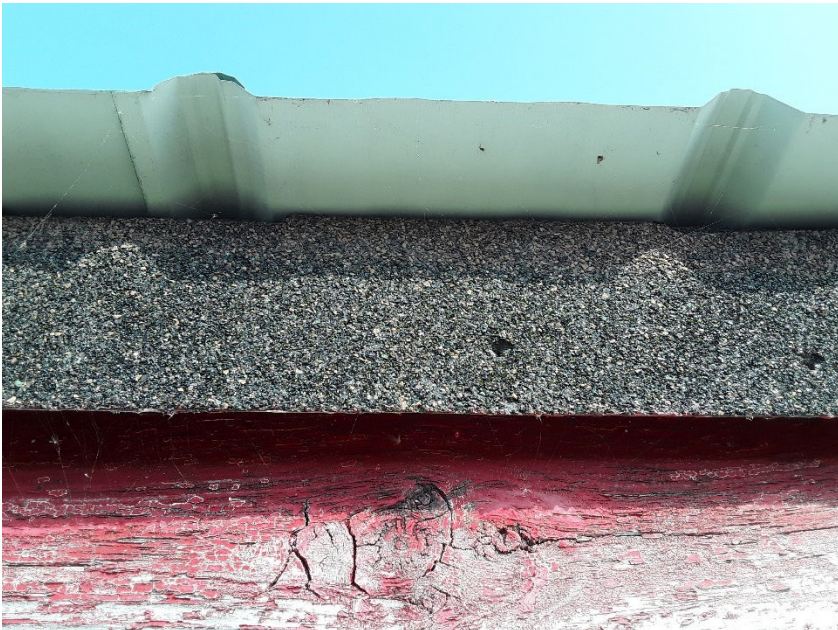
### Photograph 18

View of Roofing Shingles  
(HA17)

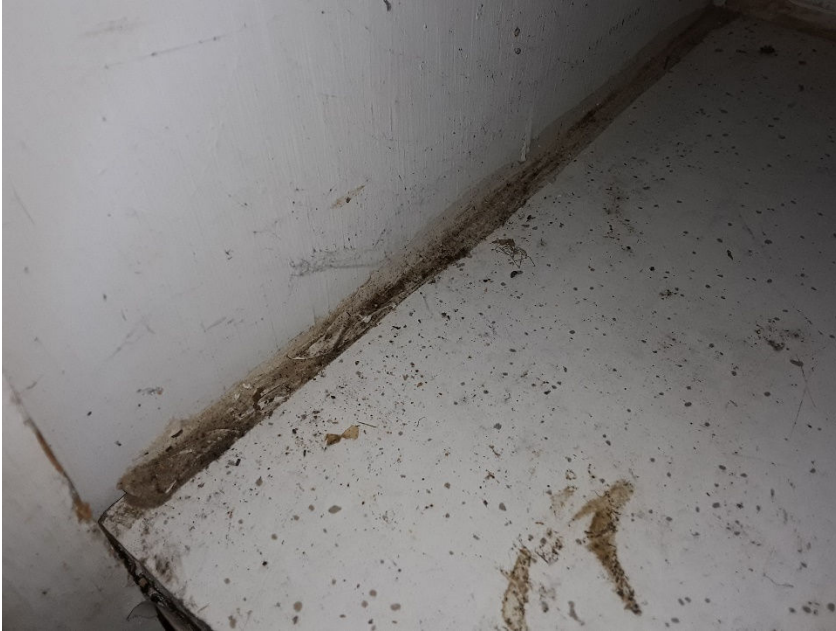
### Photograph 19

View of White Interior Building Caulk  
(HA18)

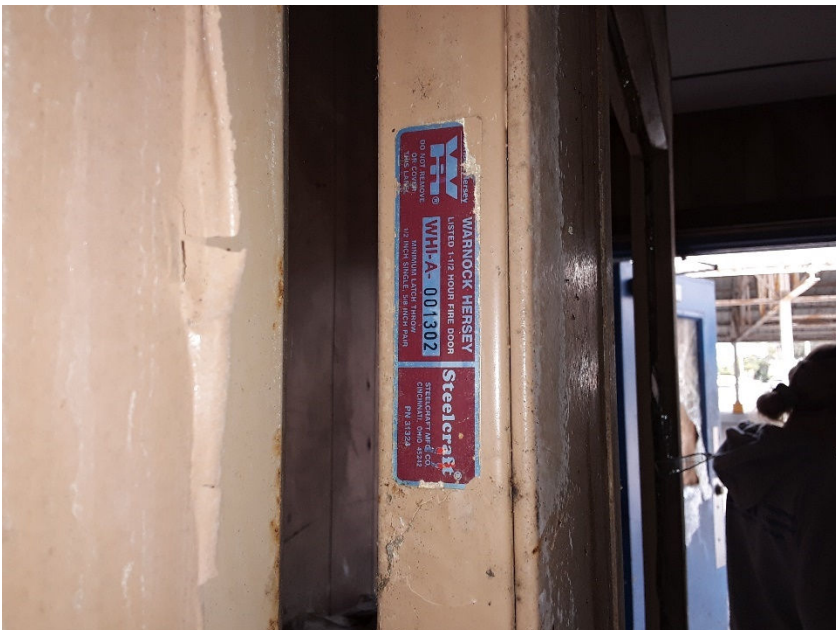
### Photograph 20

View of Tagged Metal Fire Door  
(Assumed ACM)  
(HA19)

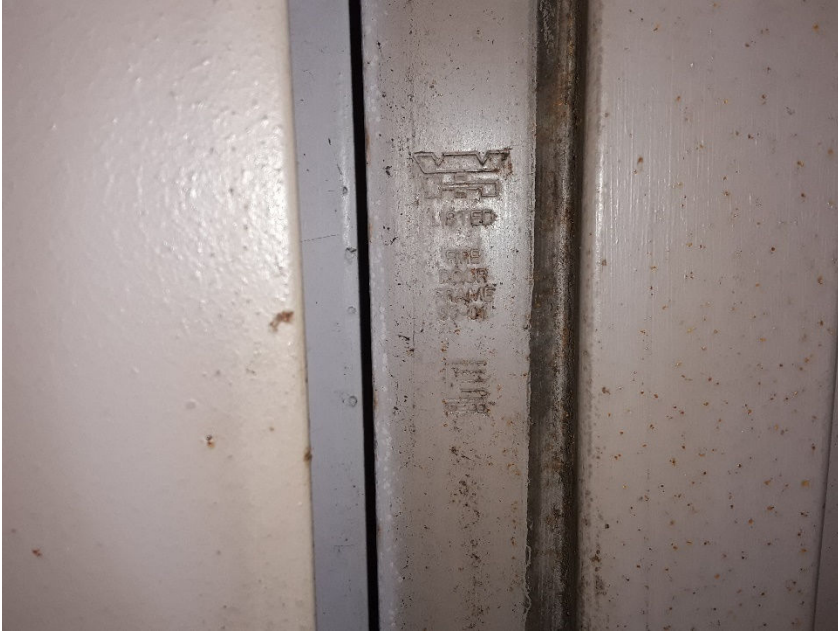
### Photograph 21

View of Tagged Metal Fire Door  
(Assumed ACM)  
(HA20)

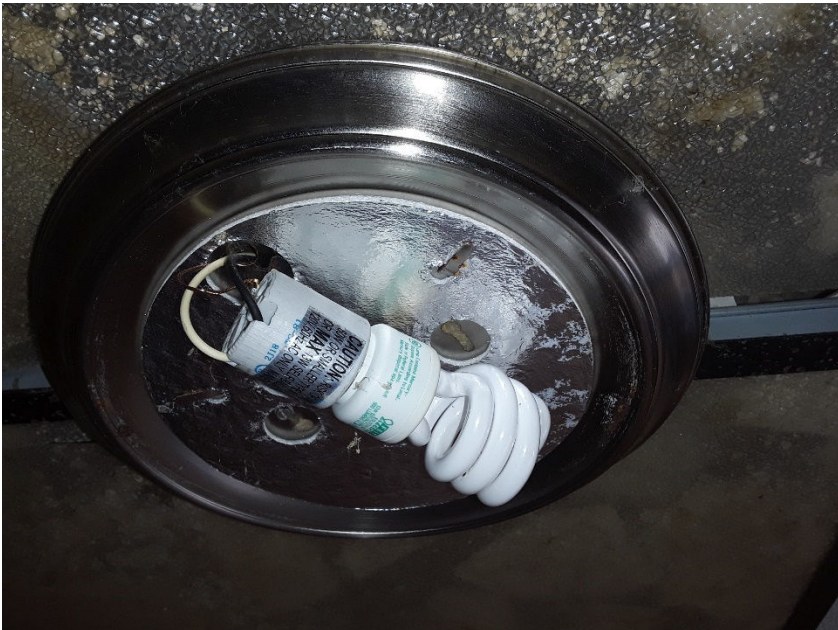
### Photograph 22

View of Light Heat Shield  
(HA21)

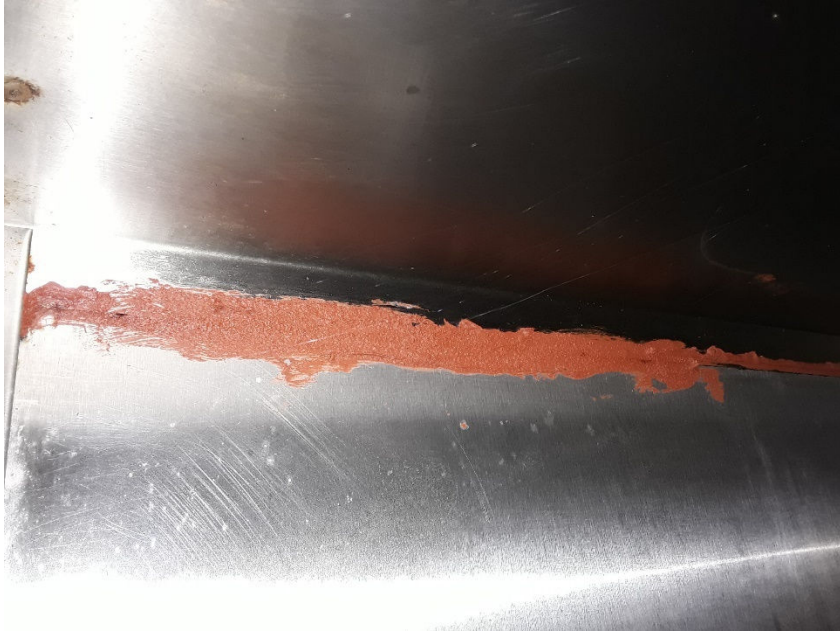
### Photograph 23

View of Red Fire Stop Caulk  
(HA22)

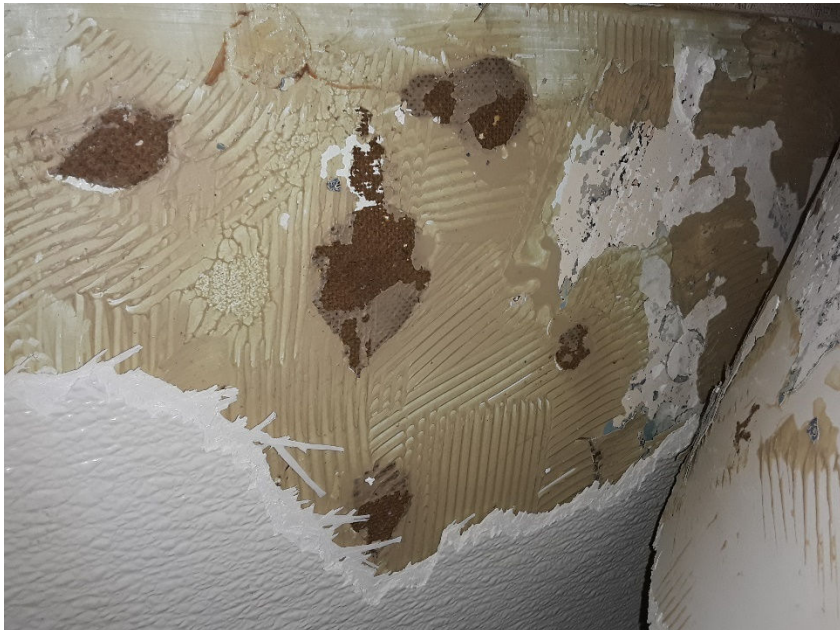
### Photograph 24

View of Fiberglass Reinforced Wall Panel  
Adhesive  
(HA23)

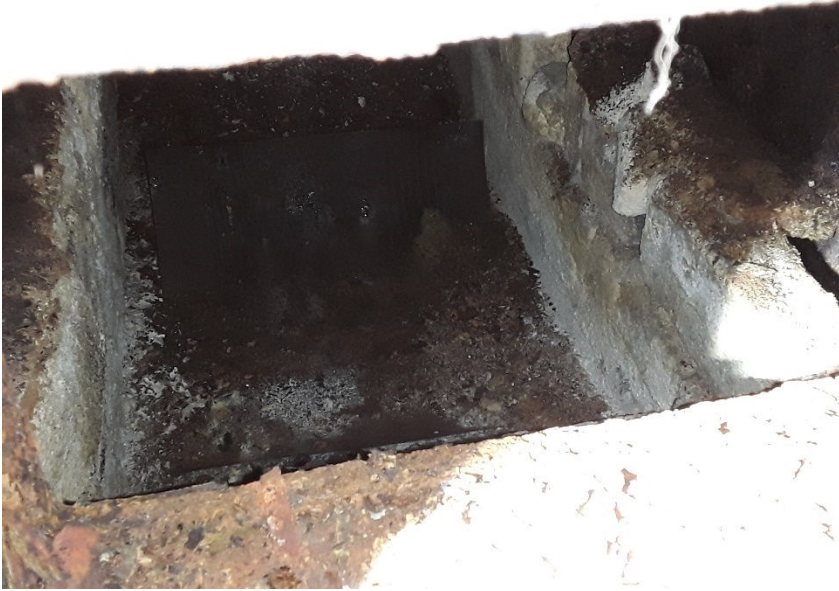
### Photograph 25

View of Interior Boiler Fire Brick  
(HA24)

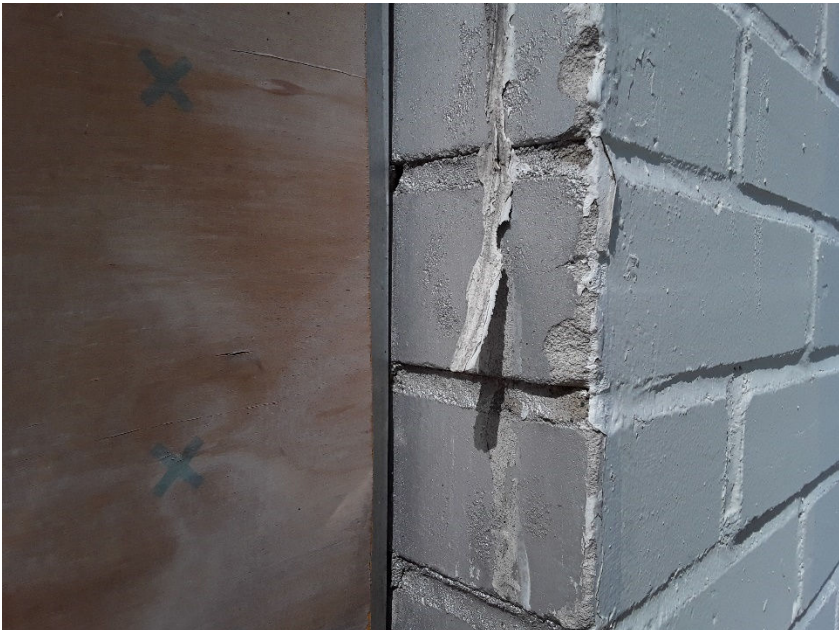
### Photograph 26

View of White Exterior Window Caulk  
(HA25)

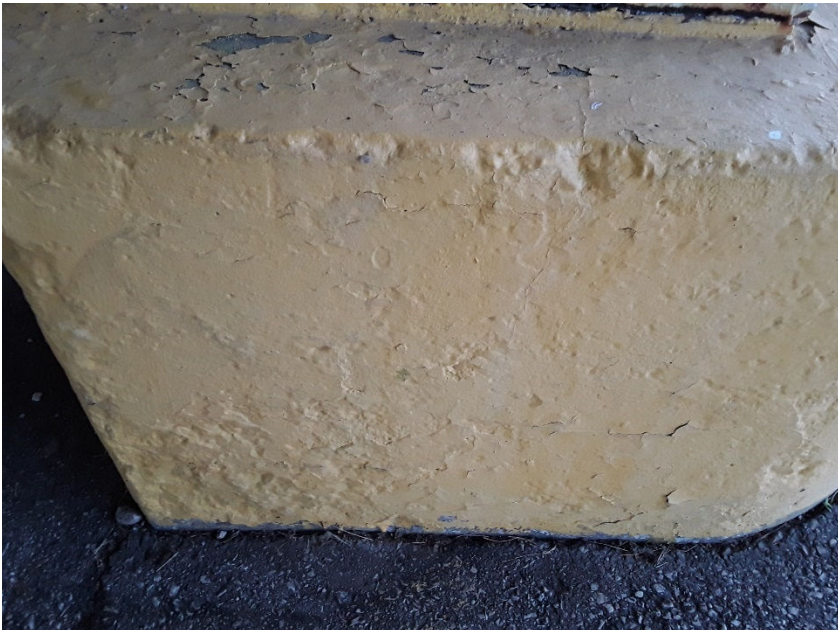
### **Photograph 28**

**Typical View of Yellow Exterior Paint on  
Concrete  
(PC-1)**

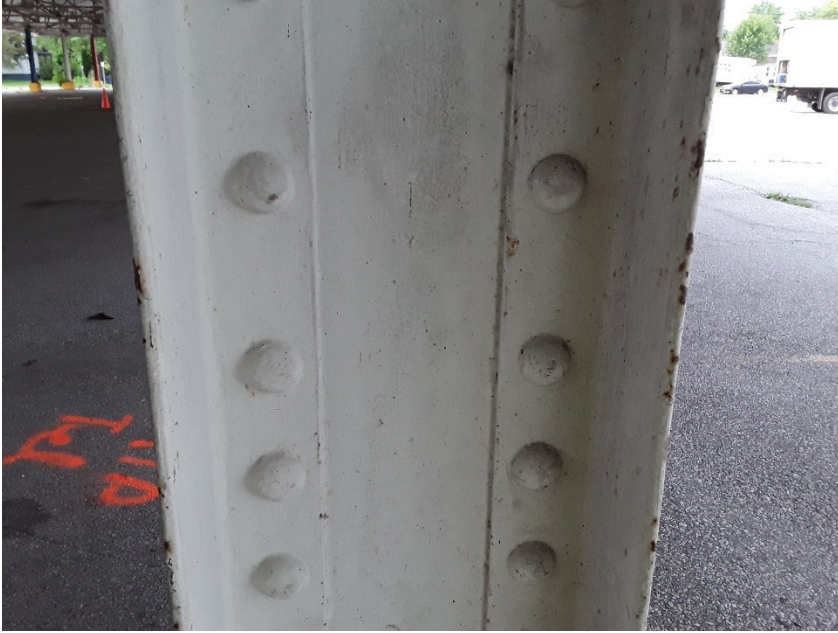
### Photograph 29

Typical View of White Exterior Paint on Metal  
(PC-2)

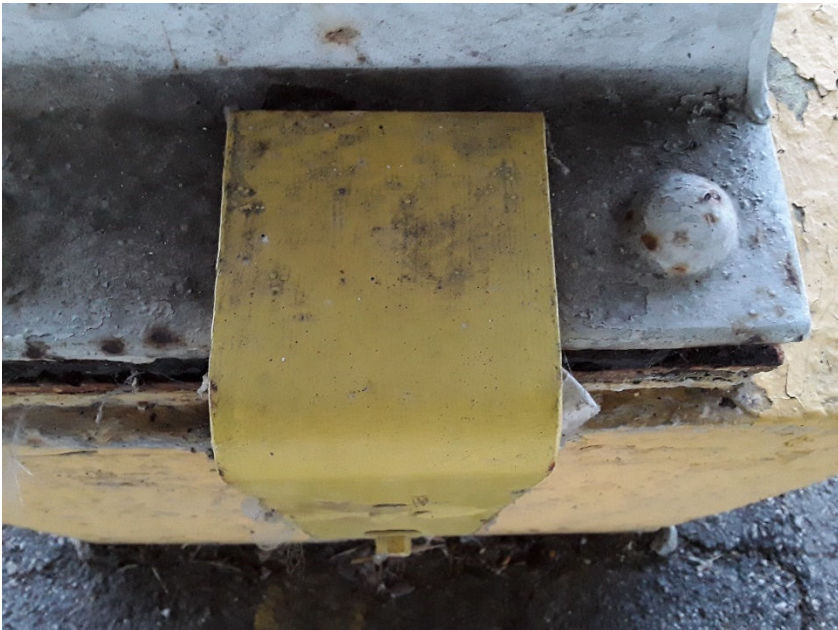
### Photograph 30

Typical View of Yellow Exterior Paint on Metal  
(PC-3)

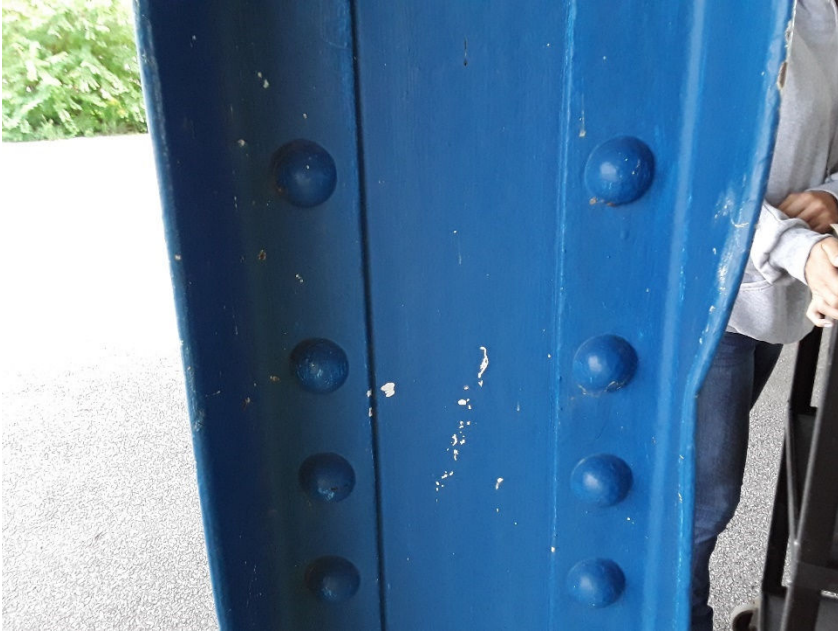
### Photograph 31

Typical View of Blue Exterior Paint on Metal  
(PC-4)

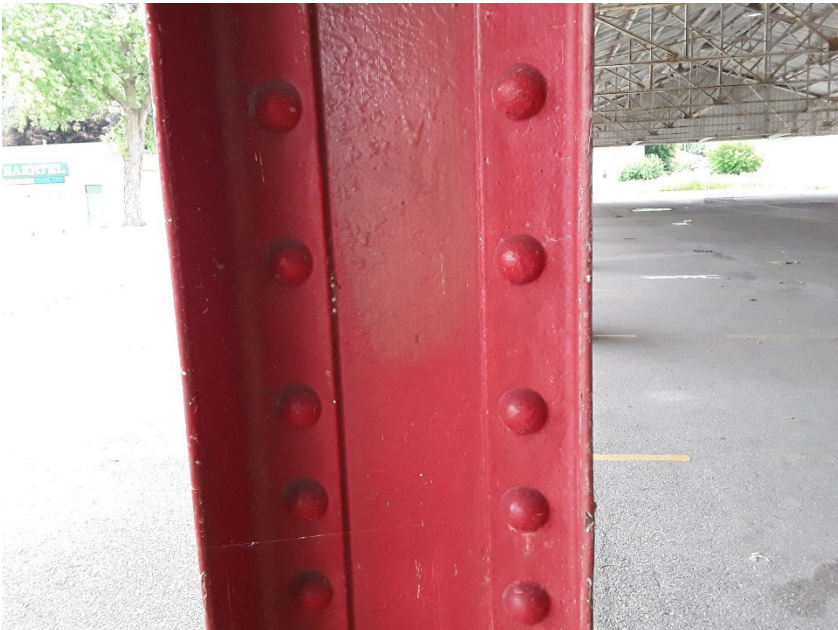
### Photograph 32

Typical View of Red Exterior Paint on Metal  
(PC-5)

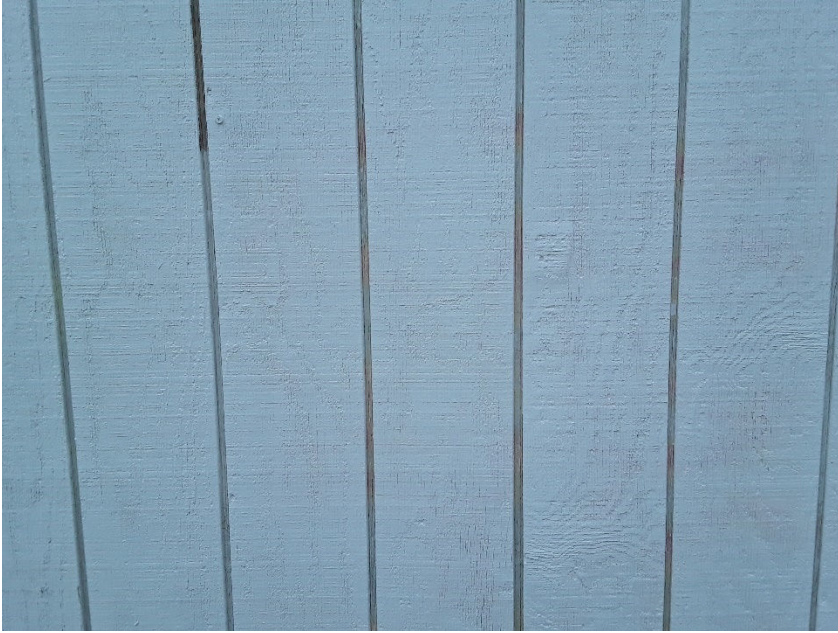
### **Photograph 33**

Typical View of White Exterior Paint on Wood  
(PC-6)

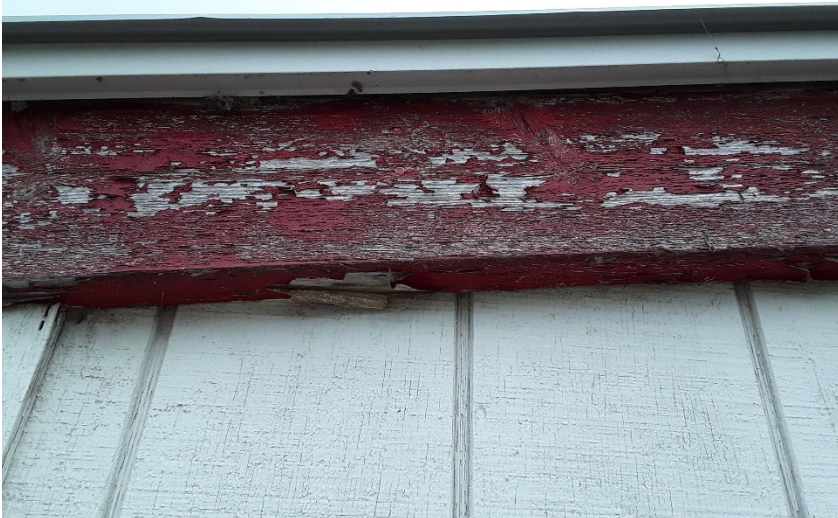
### **Photograph 34**

Typical View of Red Exterior Paint on Wood  
(PC-7)

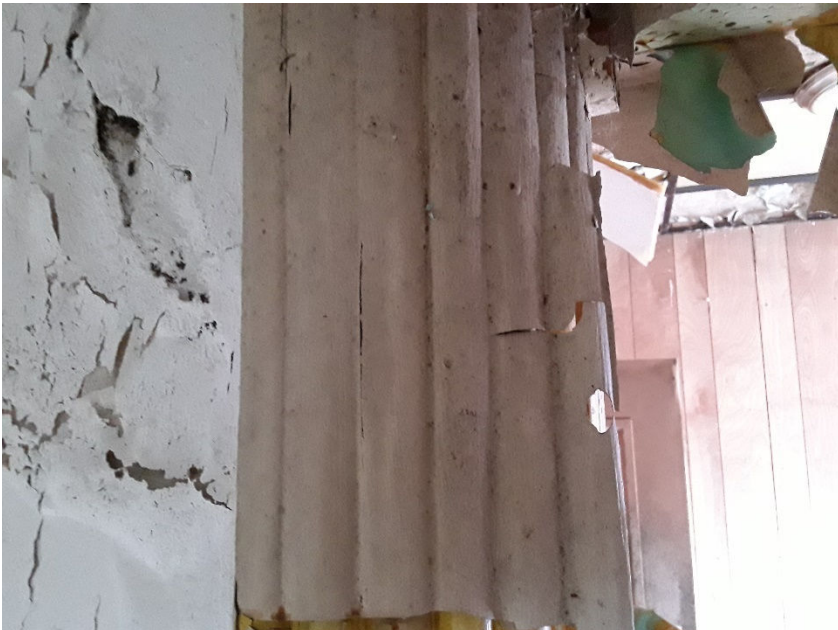
### **Photograph 36**

Typical View of Beige Interior Paint on Wood  
(PC-9)

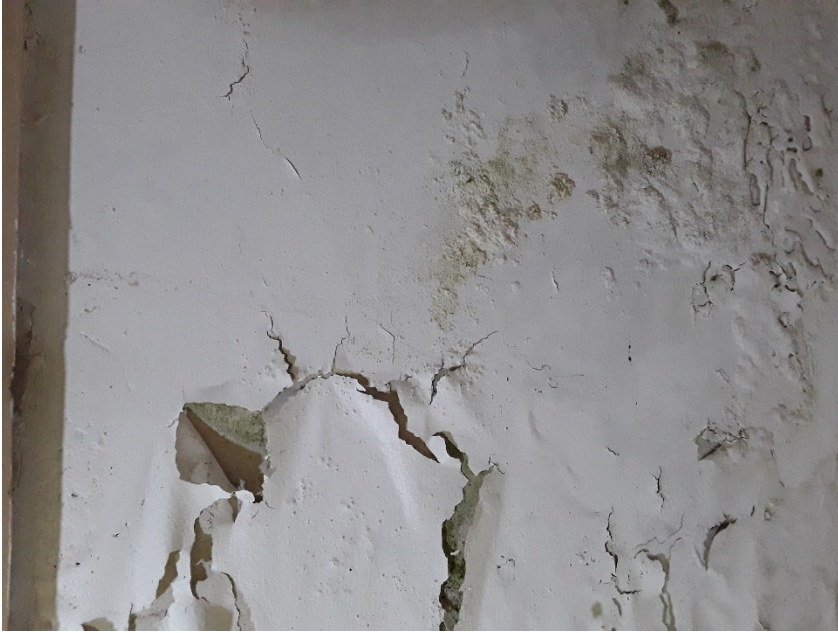
### Photograph 37

Typical View of White Interior Paint on Plaster  
(PC-10)

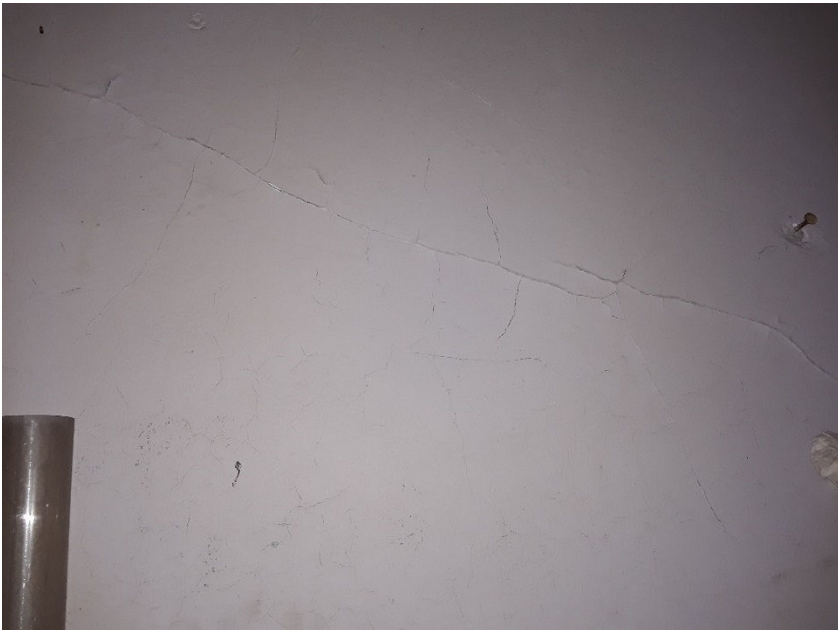
### Photograph 38

Typical View of Blue Interior Paint on Plaster  
(PC-11)

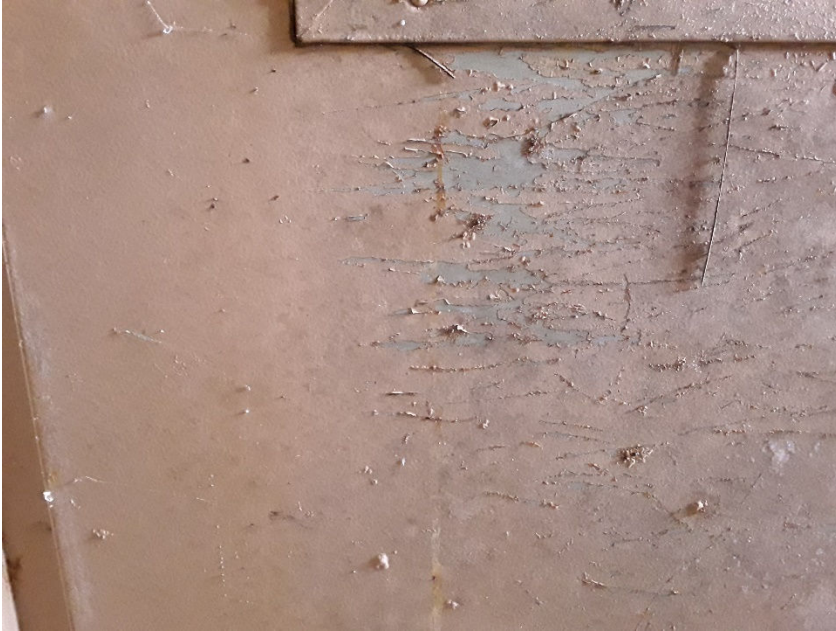
### **Photograph 39**

Typical View of Brown Interior Paint on Metal  
(PC-12)

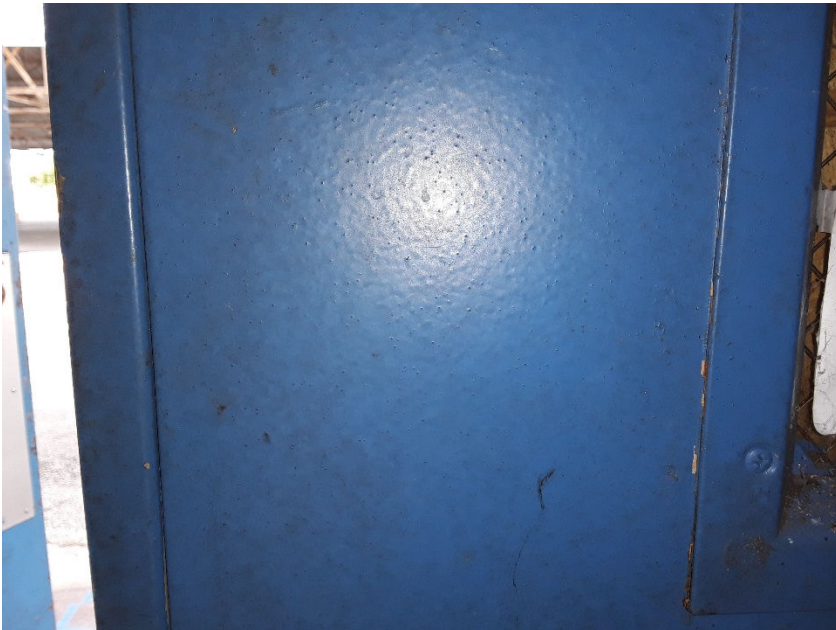
### **Photograph 40**

Typical View of Blue Interior Paint on Metal  
(PC-13)

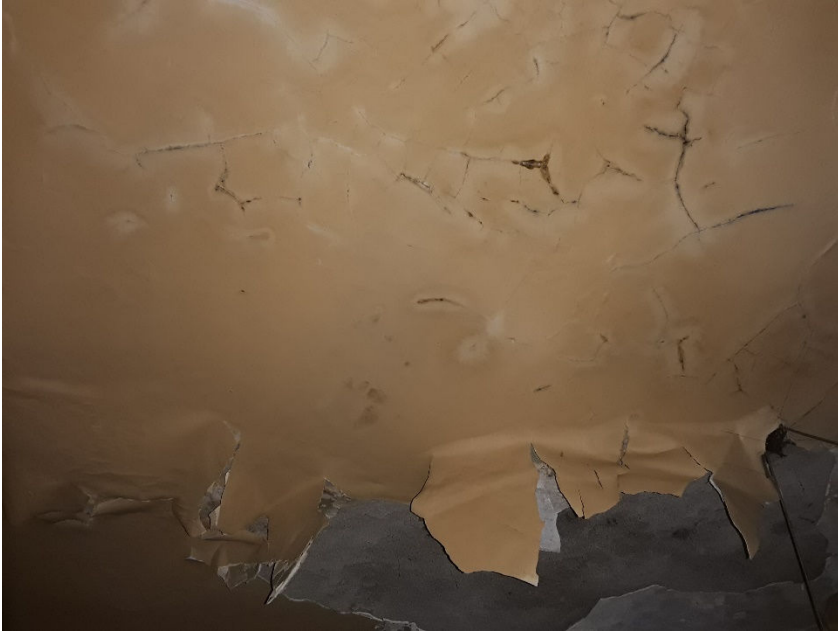
### **Photograph 41**

Typical View of Dark Yellow Interior Paint on  
Plaster  
(PC-14)
