# Pre-Demolition Hazardous Materials Survey

Former YMCA Building  
111 North Madison Avenue  
Bay City, Michigan 48708

**PROJECT #** 11146s2-2-194

**DATE** November 9, 2017

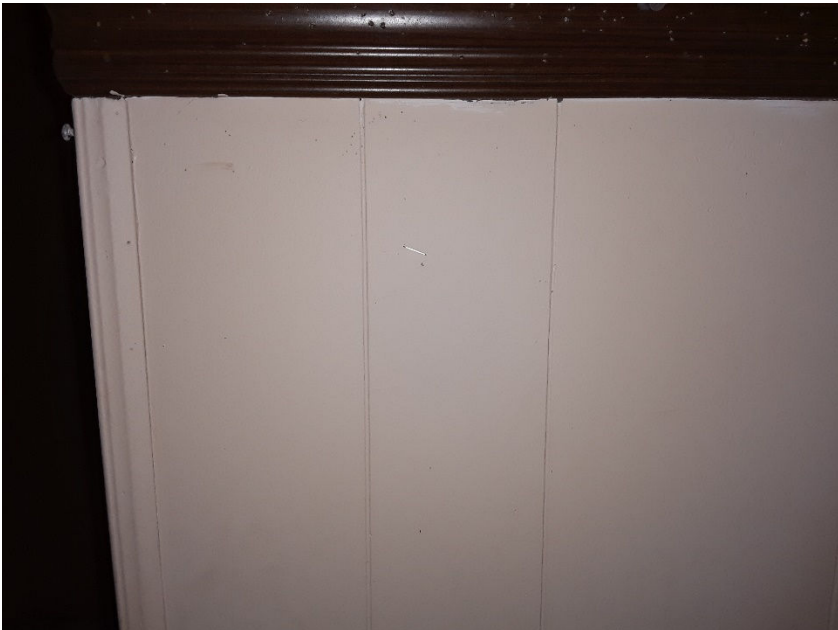
### **Photograph 42**

Typical View of Tan Interior Paint on Wood  
Paneling  
(PC-15)

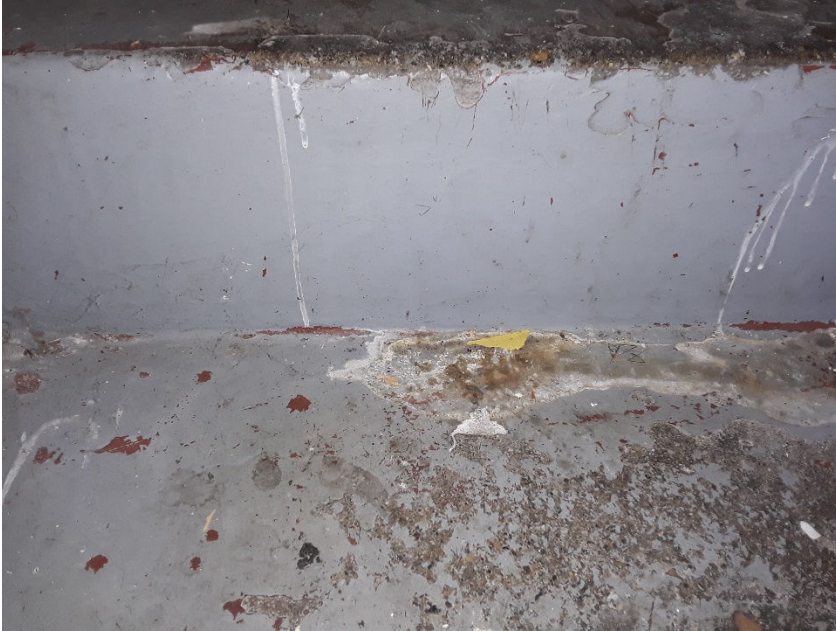
### **Photograph 43**

Typical View of Grey Interior Paint on Concrete  
(PC-16)

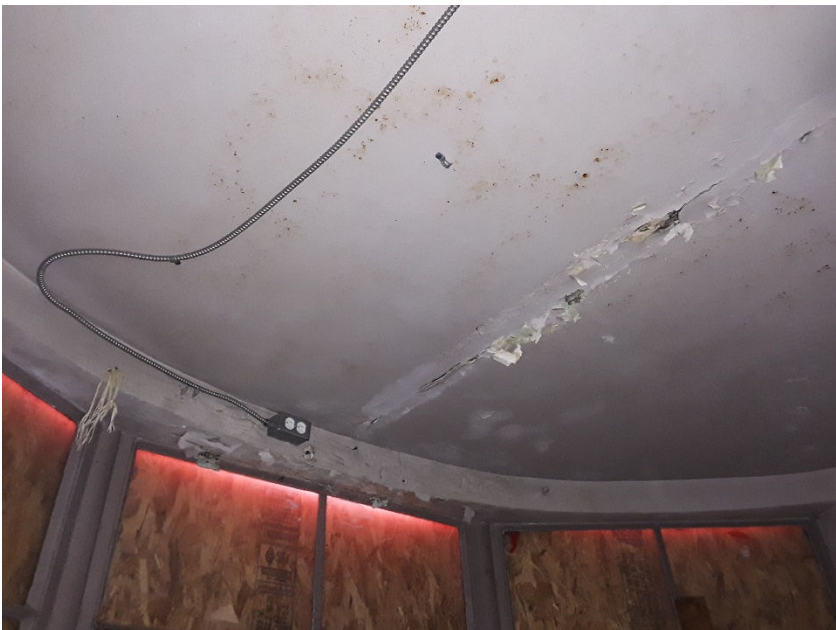
### **Photograph 44**

Typical View of Lavender Interior Paint on  
Plaster  
(PC-17)

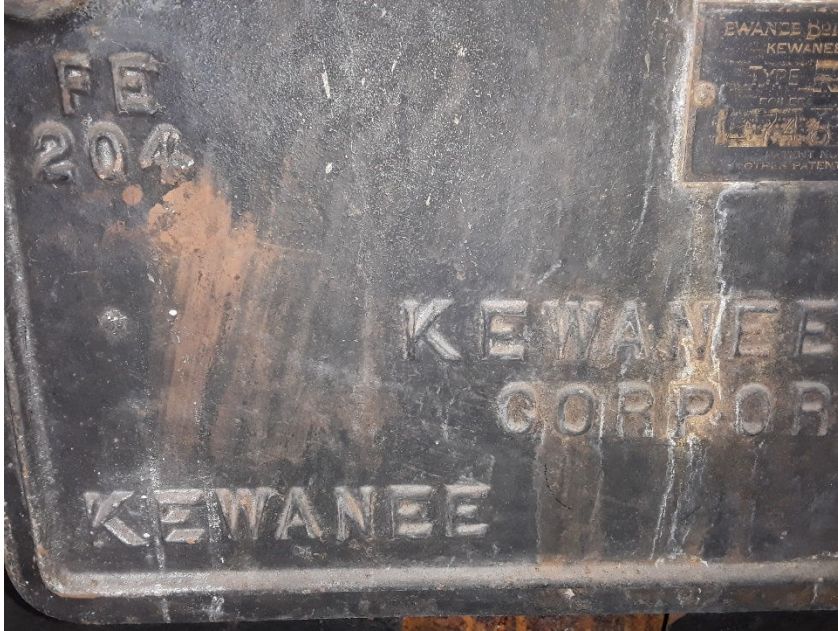
### Photograph 45

Typical View of Black Interior Paint on Boiler  
(PC-18)

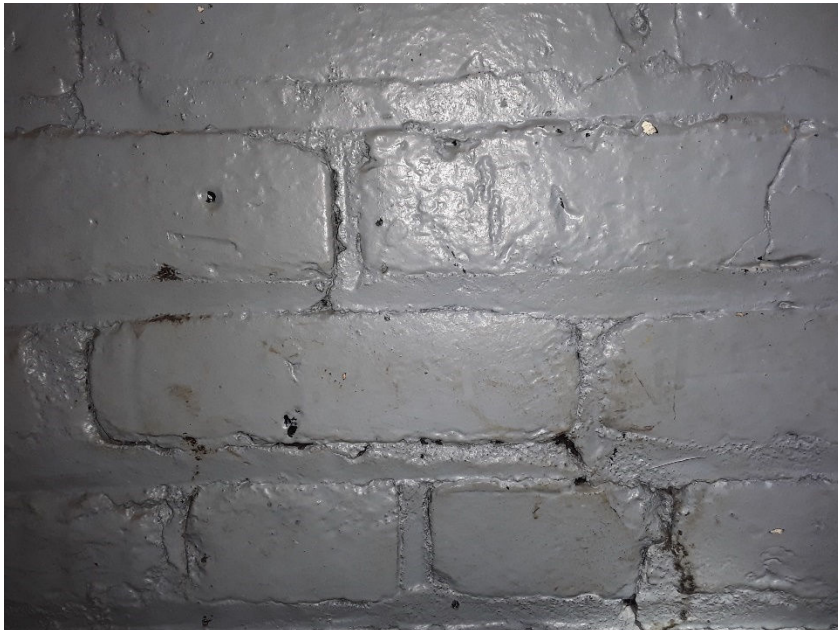
### Photograph 46

Typical View of Grey Interior Paint on Brick  
(PC-19)

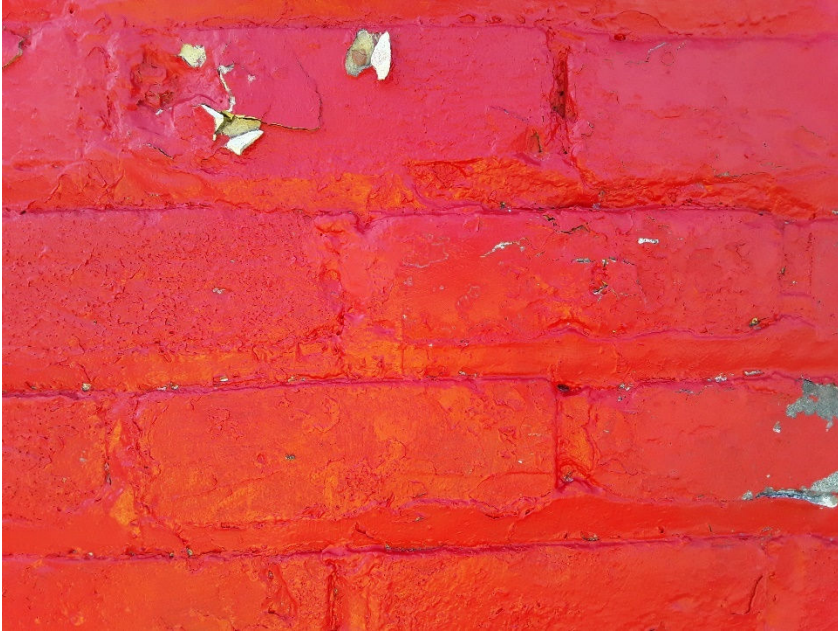
### **Photograph 47**

Typical View of Red Exterior Paint on Brick  
(PC-20)

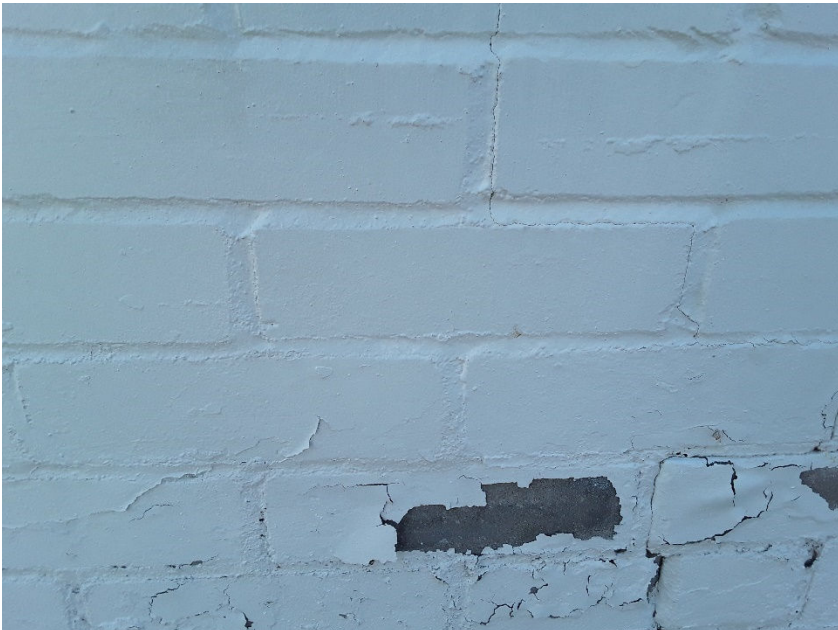
### **Photograph 48**

Typical View of White Exterior Paint on Brick  
(PC-21)

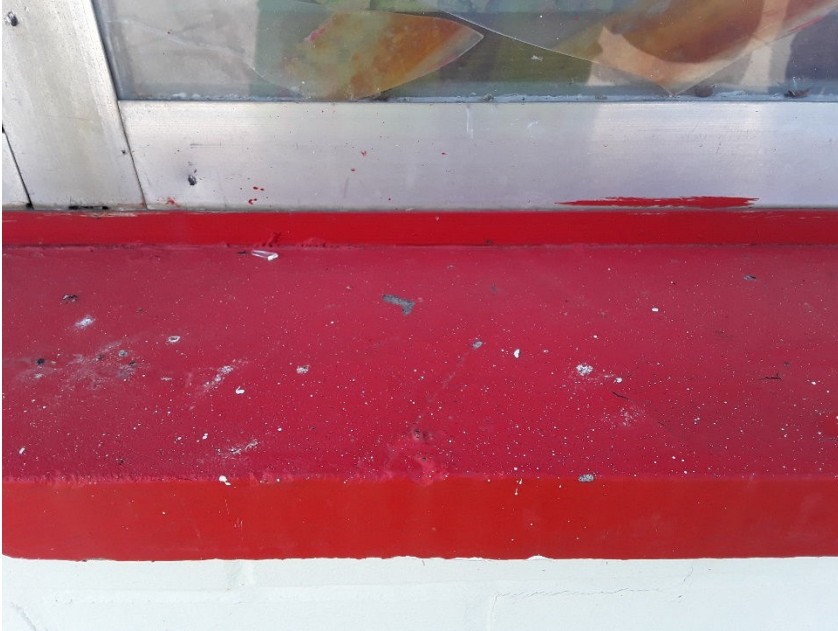
### **Photograph 49**

Typical View of Red Exterior Paint on Concrete  
(PC-22)

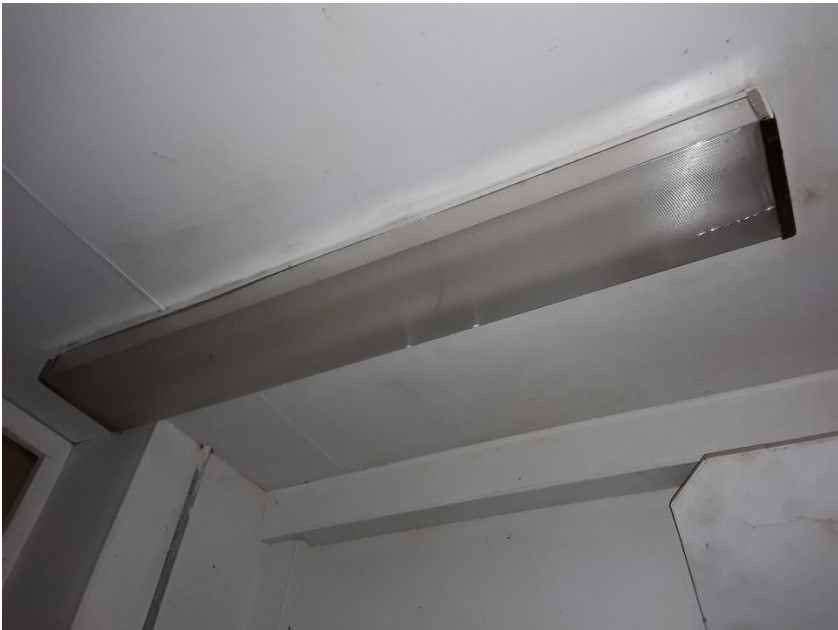
### **Photograph 50**

Typical View of Fluorescent Bulbs Containing  
Ballasts

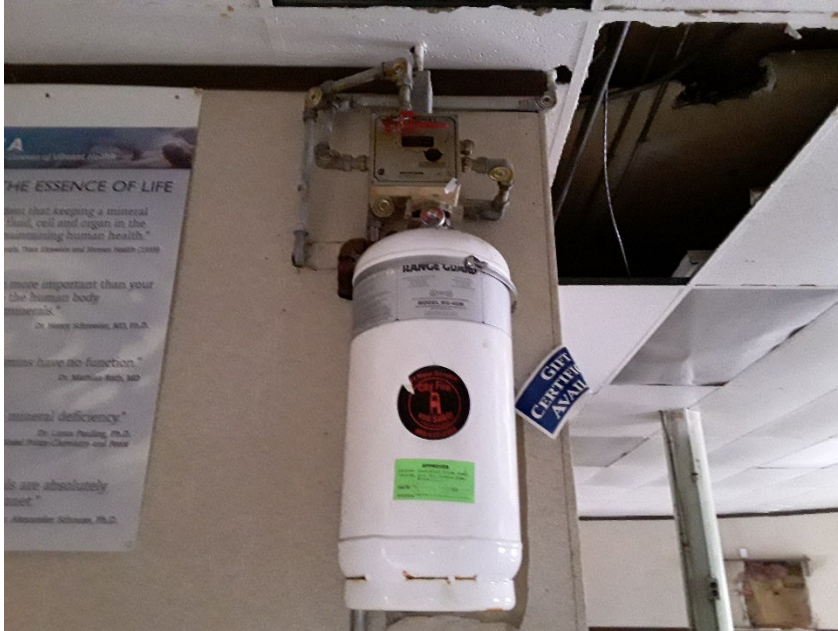
### Photograph 51

Typical View of Fire Extinguisher Systems

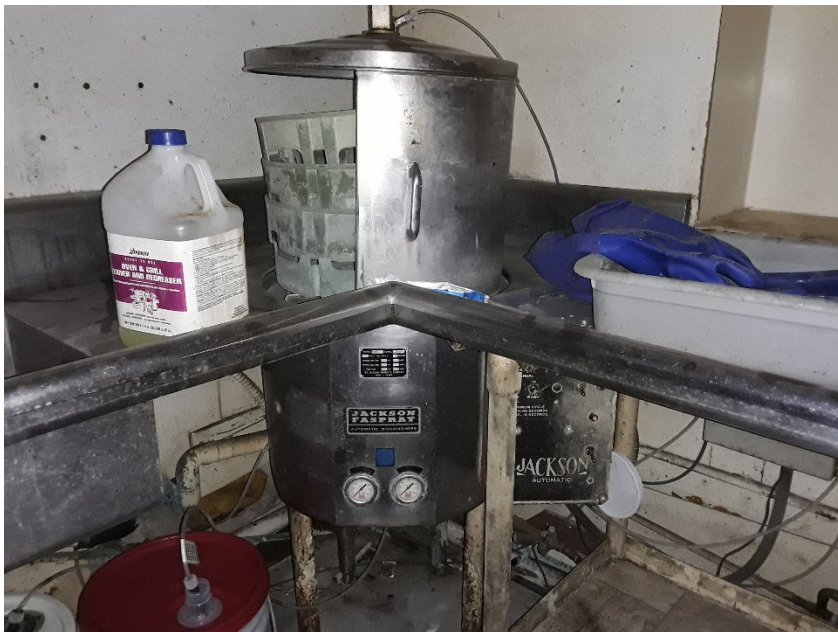
### Photograph 52

Typical View of Dishwasher

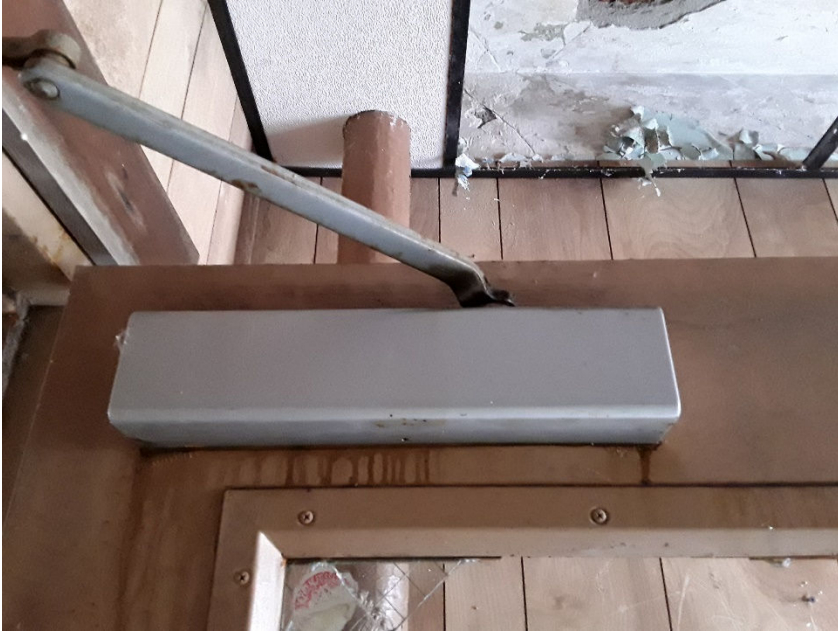
### Photograph 53

Typical View of Hydraulic Door Hinge

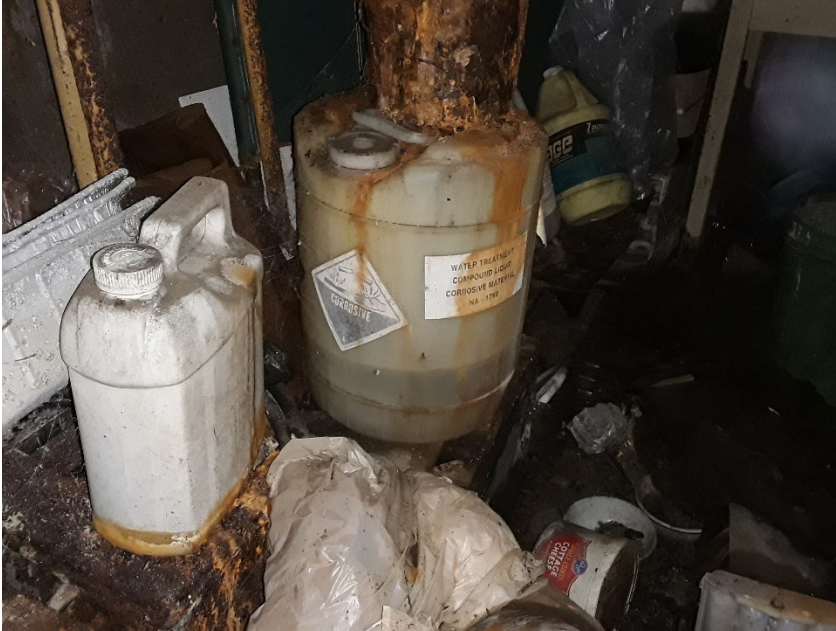
### Photograph 55

Typical View of Water Treatment Compound Liquid

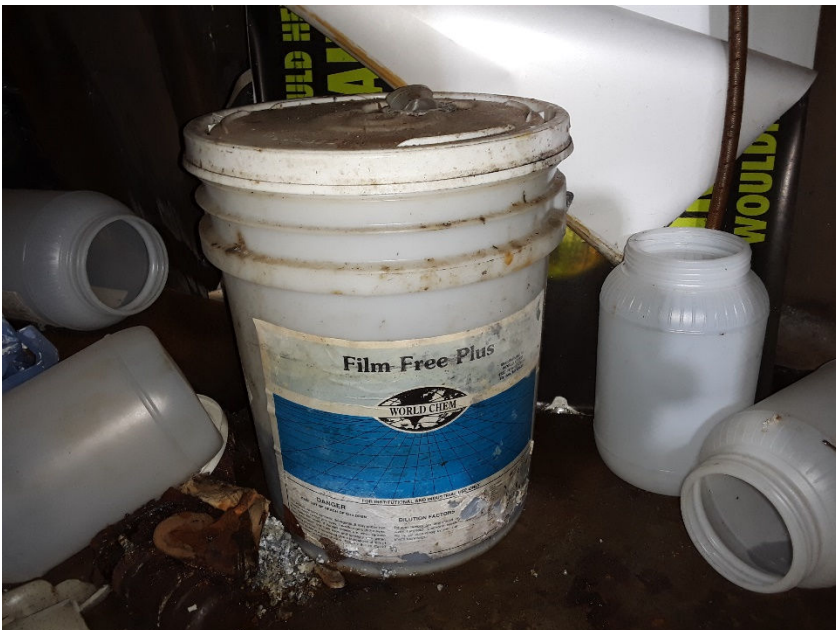
### Photograph 56

Typical View of Film Free Plus

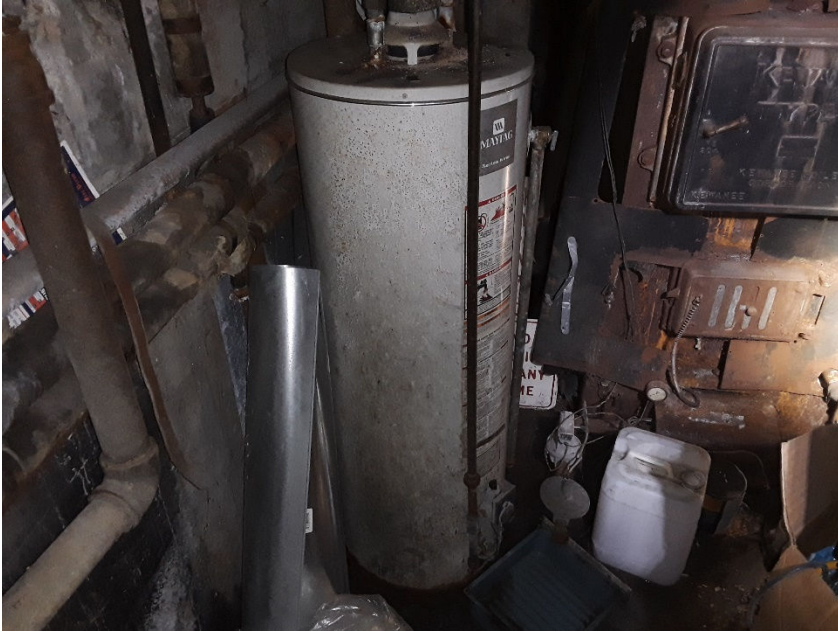
### Photograph 57

Typical View of Water Heater

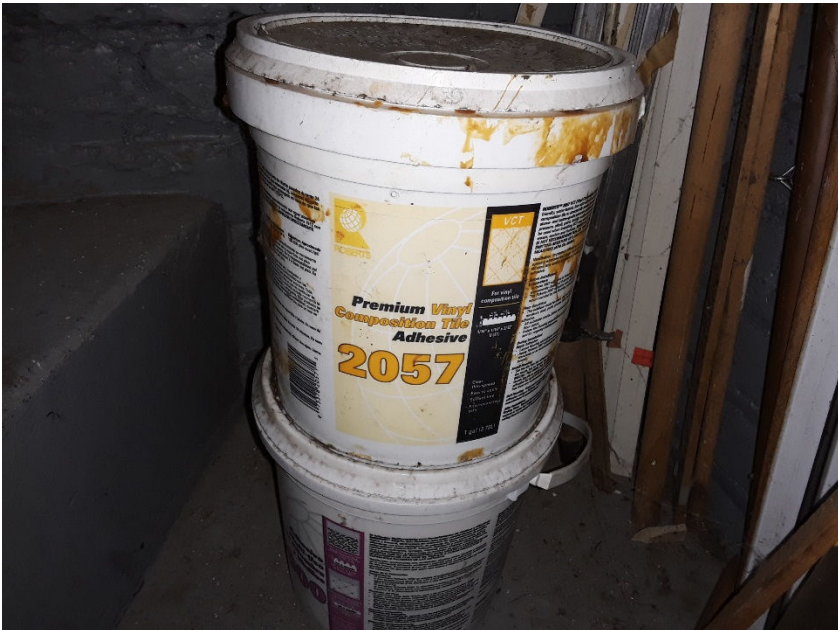
### Photograph 58

Typical View of Vinyl Tile Adhesive

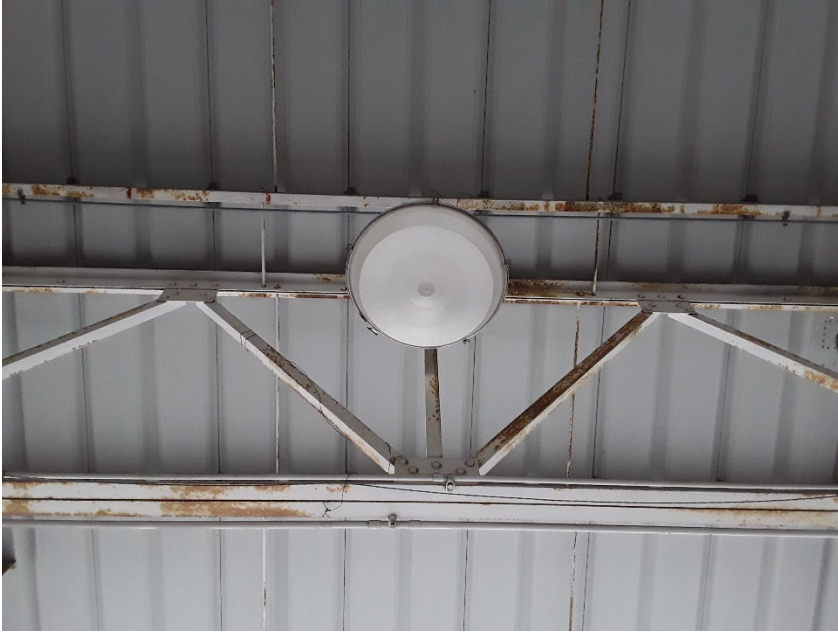
### **Photograph 59**

Typical View of High Intensity Discharge  
Lighting

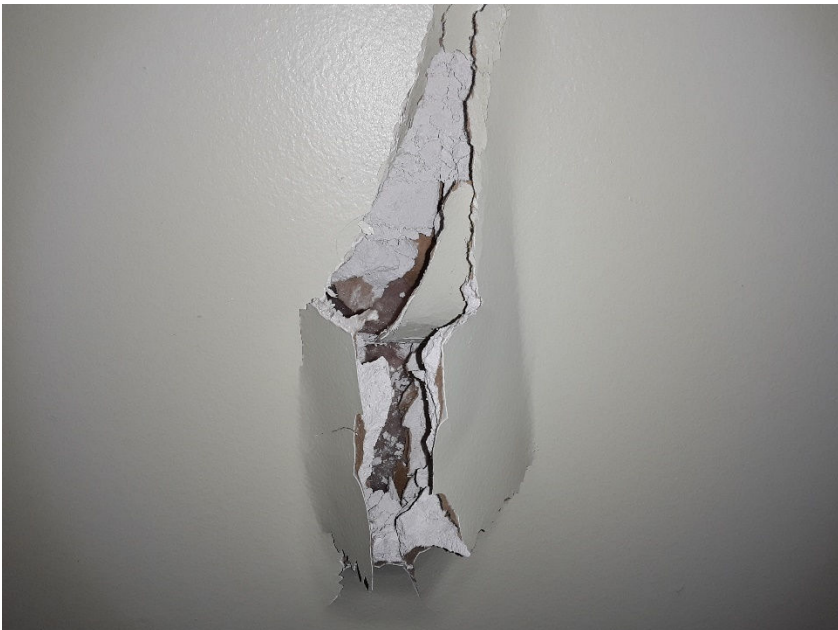
### **Photograph 2**

View of Drywall and Joint Compound  
(HA1)

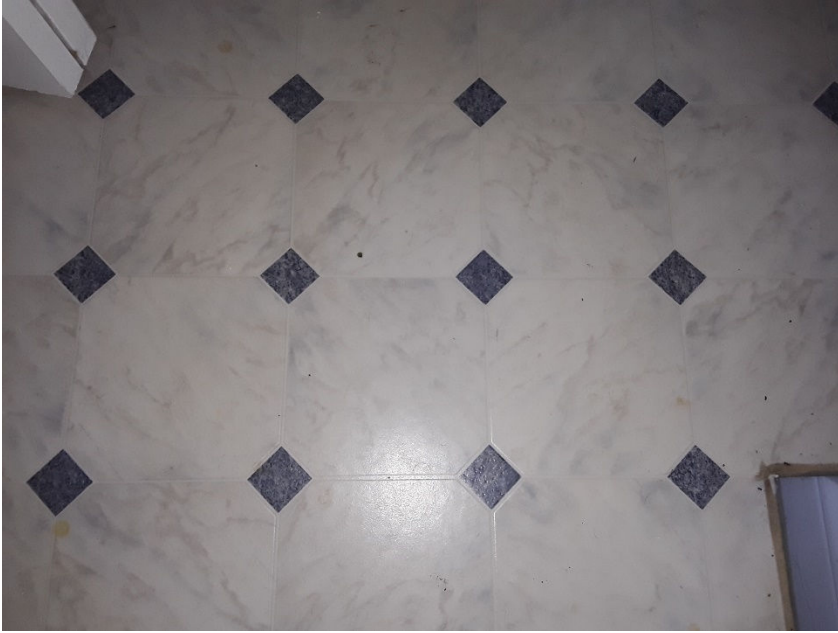
### Photograph 3

View of White with Blue Diamond Pattern  
Flooring  
(HA2)

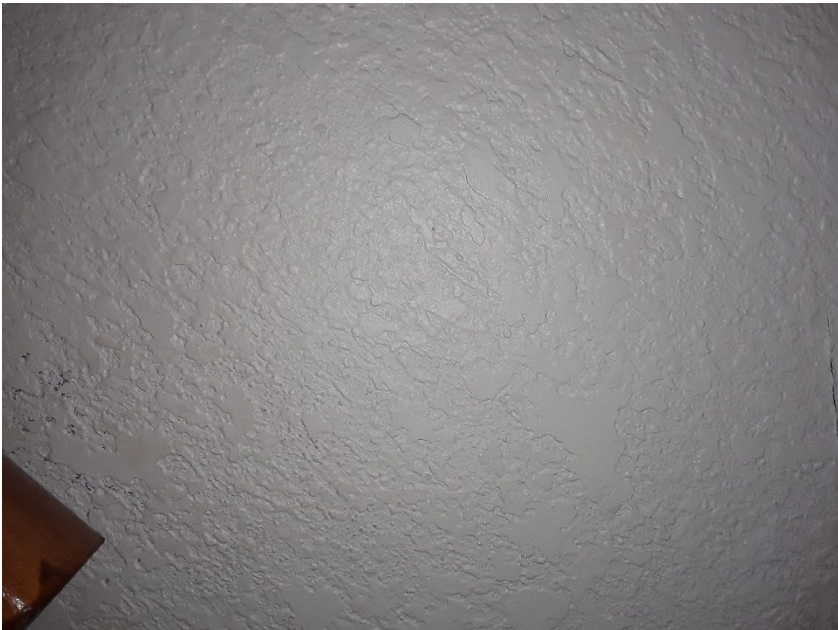
### Photograph 4

View of Textured Paint  
(HA3)

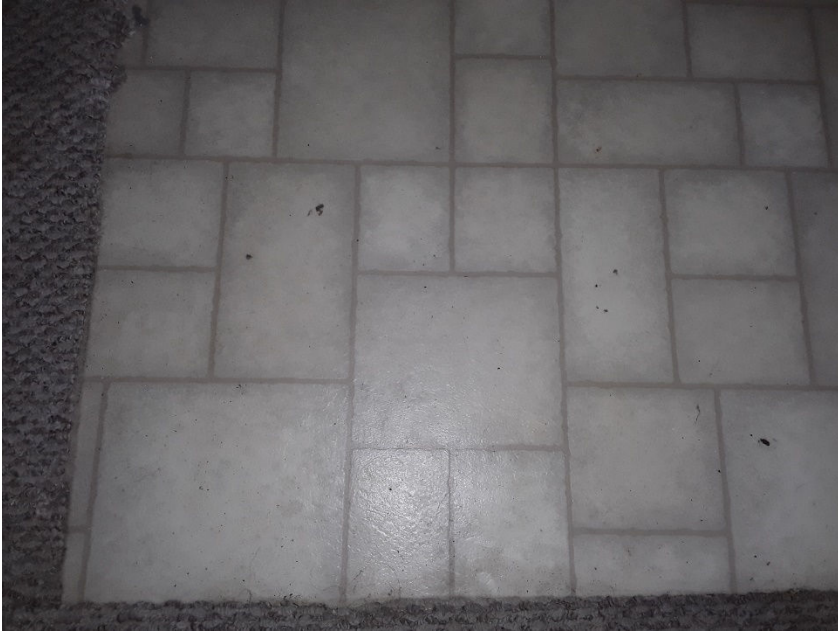
### Photograph 5

View of White Square Pattern Flooring with  
Layers  
(HA4)

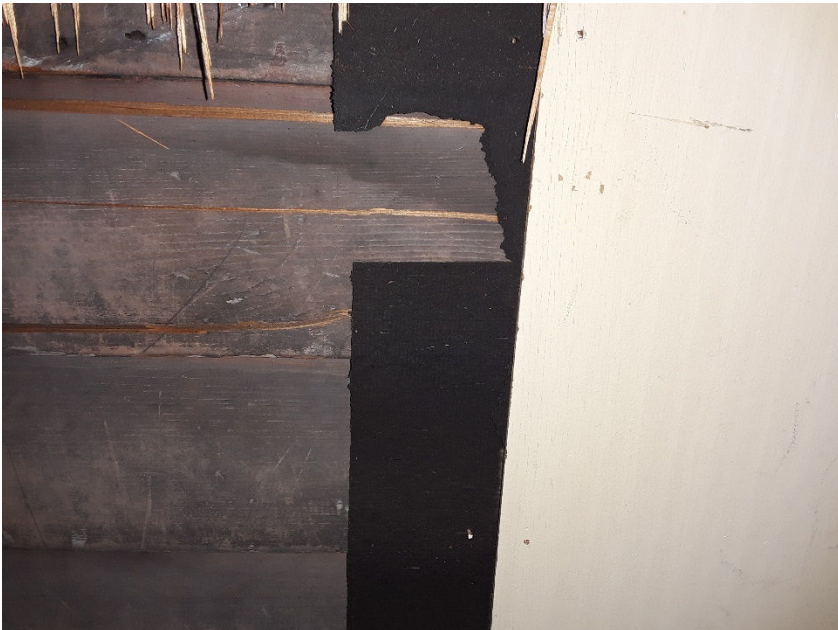
### Photograph 6

View of Black Paper Under Paneling  
(HA5)

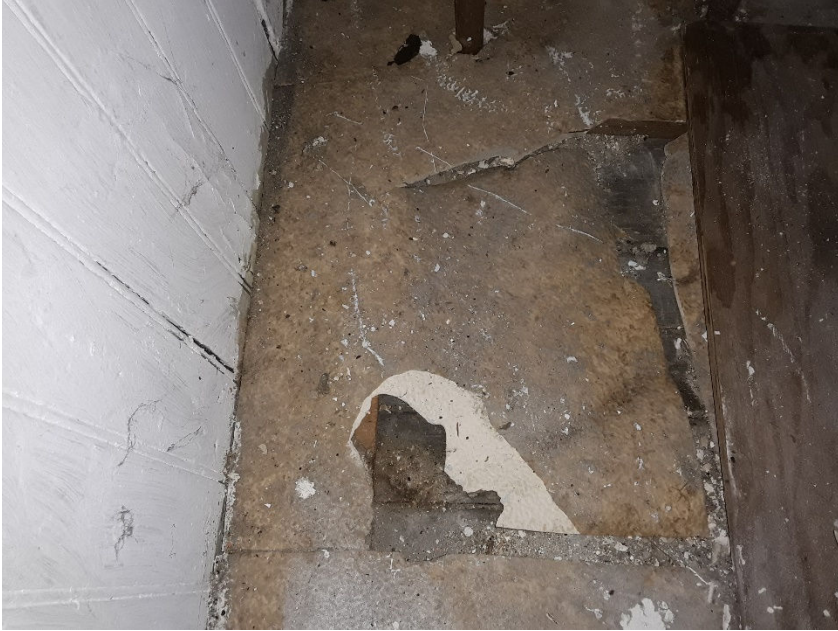
### Photograph 7

View of Yellow Flooring Under Wood Plank  
Flooring  
(HA6)

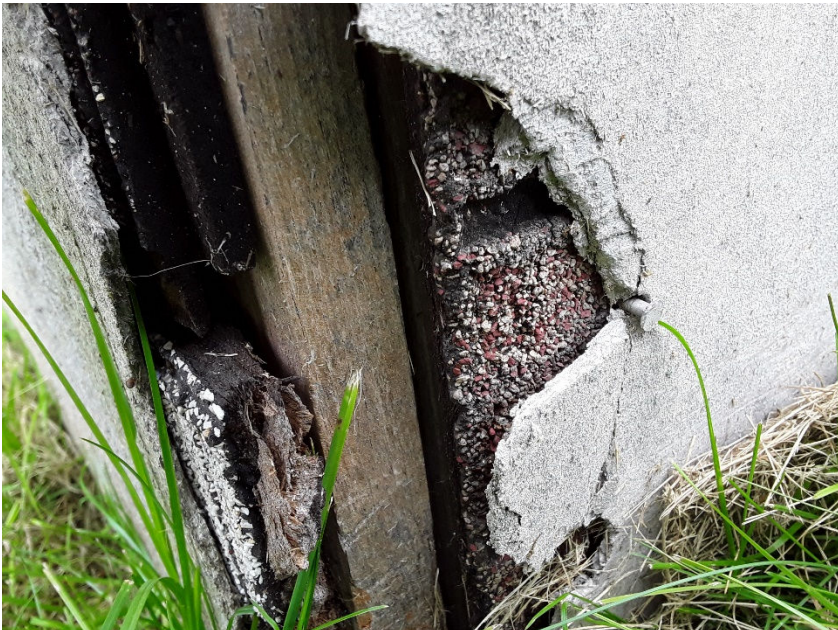
### Photograph 8

View of Insulbrick Exterior Siding  
(HA7)

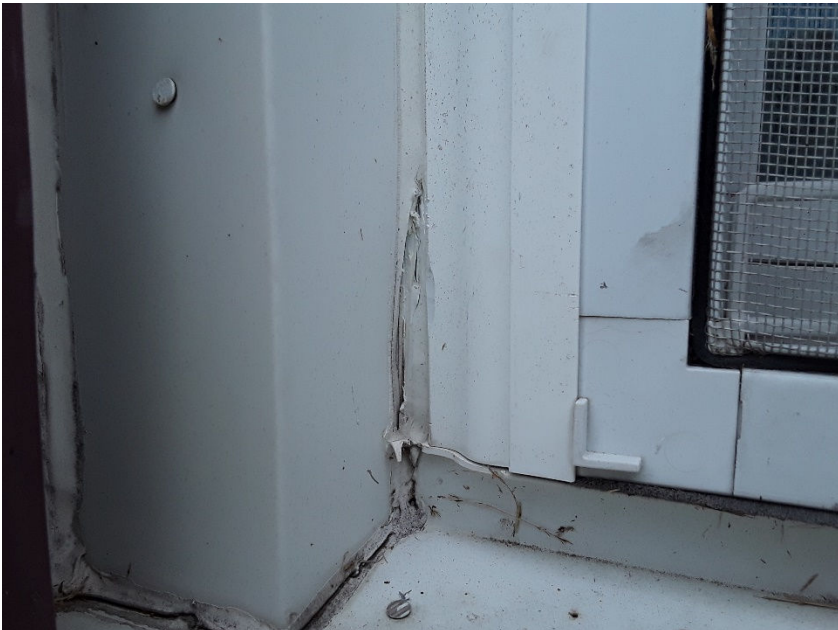
### **Photograph 10**

**View of White Caulk Around Exterior Windows  
(HA9)**

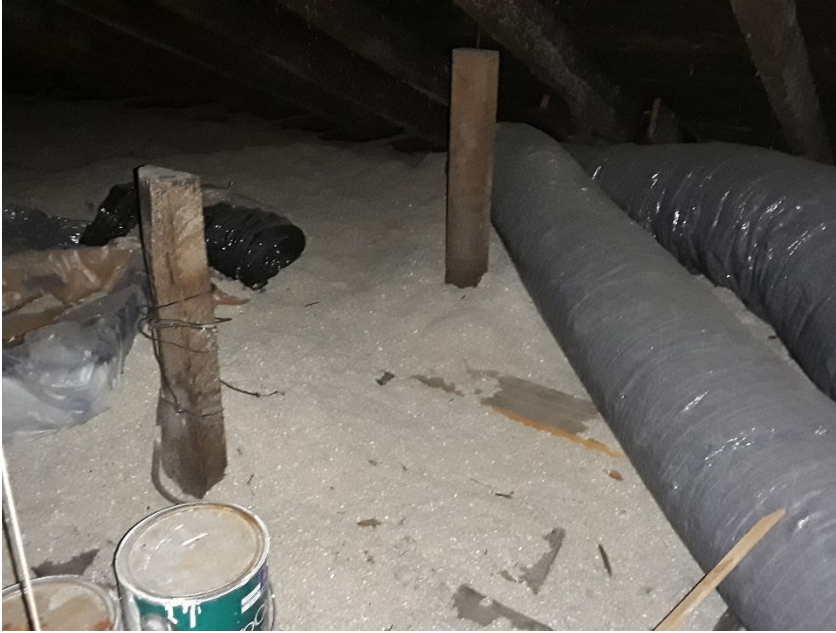
### **Photograph 11**

View of Cellulose Insulation  
(HA10)

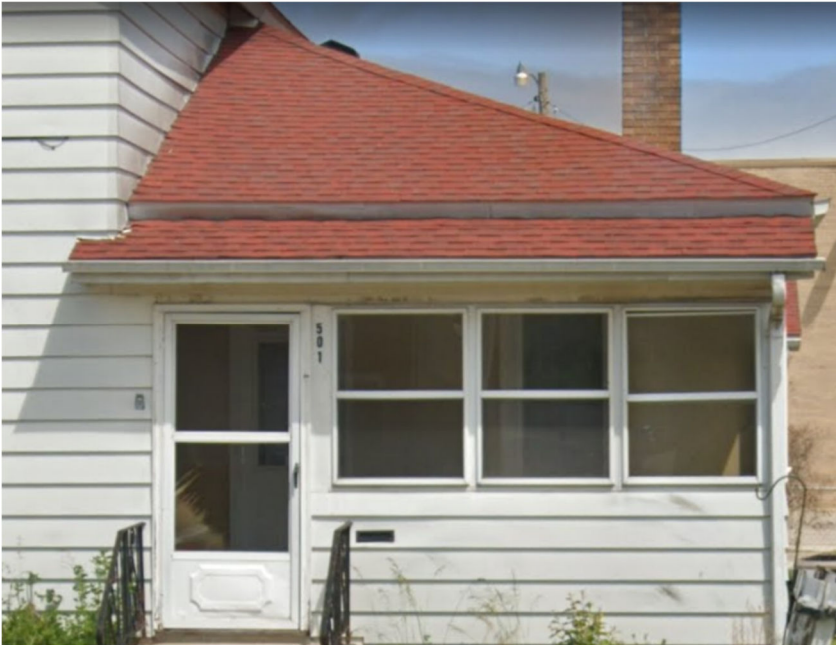
### **Photograph 12**

View of Roofing Materials – House  
(HA11)

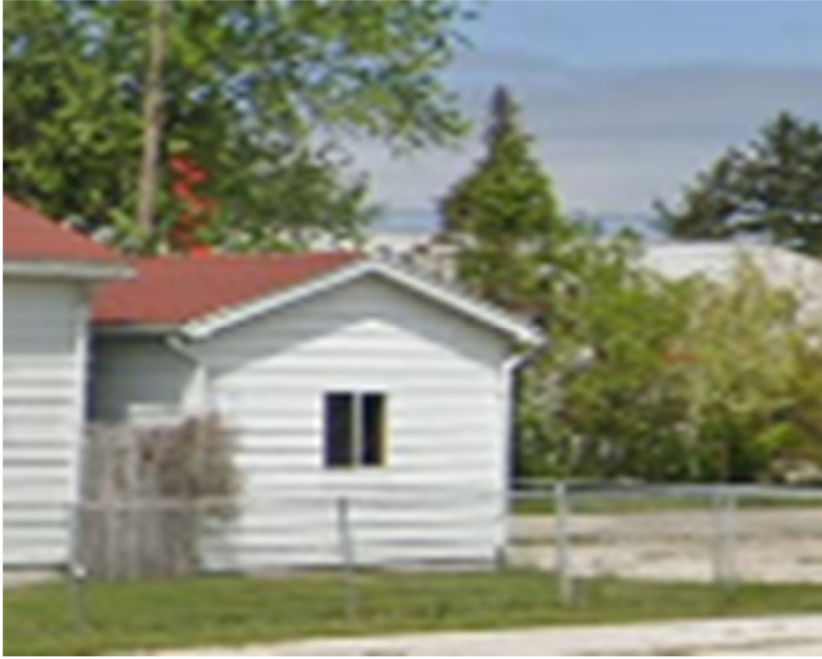
### **Photograph 13**

View of Roofing Materials – Garage  
(HA12)

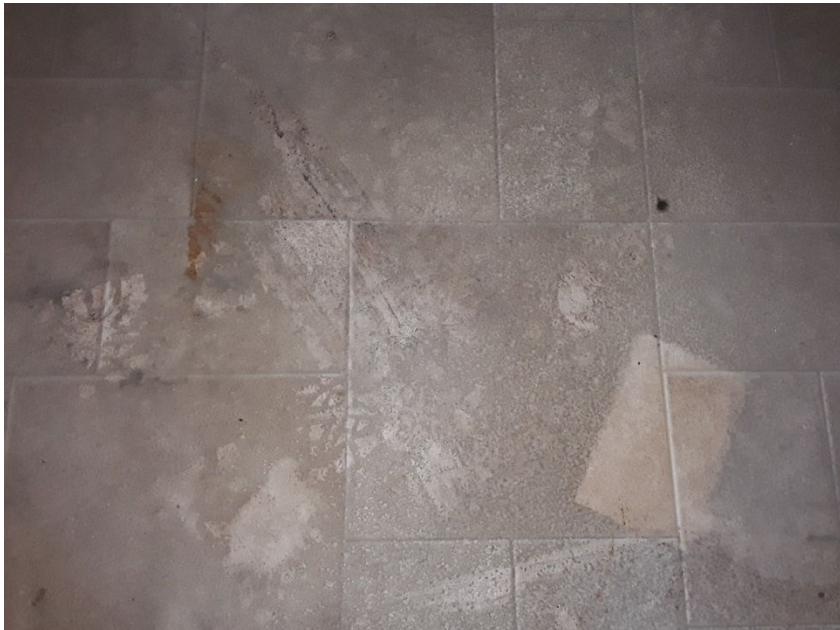
### **Photograph 14**

View of Tan Square Pattern Sheet Flooring and  
Adhesive  
(HA13)

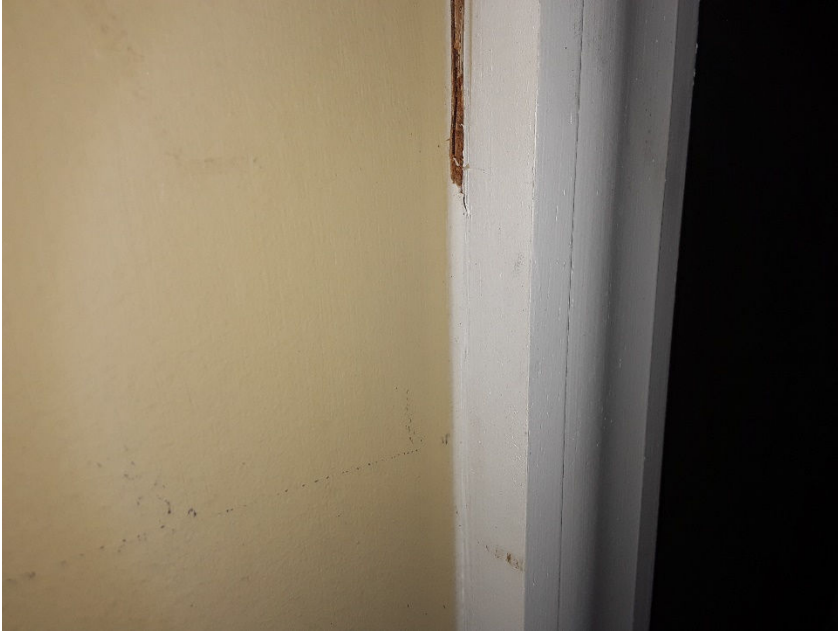
### Photograph 15

View of White Interior Building Caulk  
(HA14)

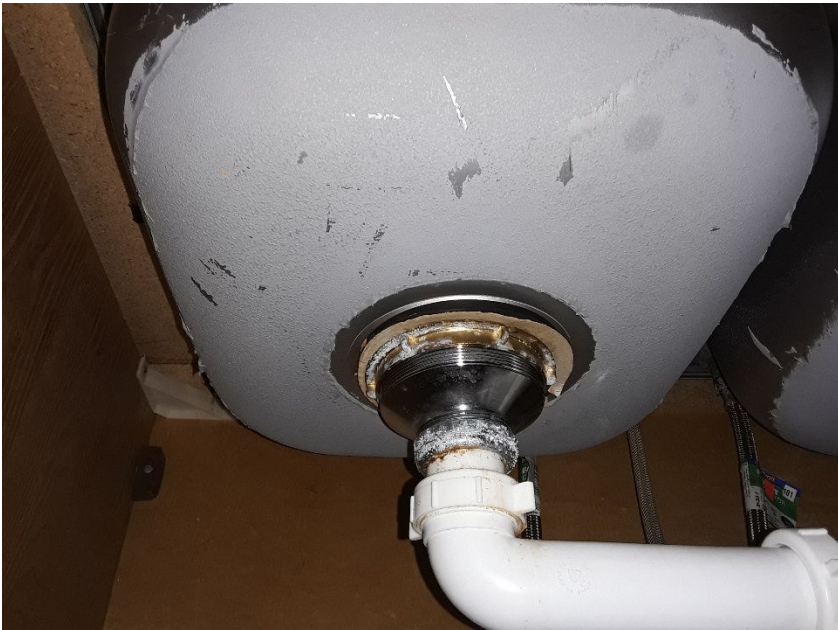
### Photograph 16

View of Grey Sink Undercoating  
(HA15)

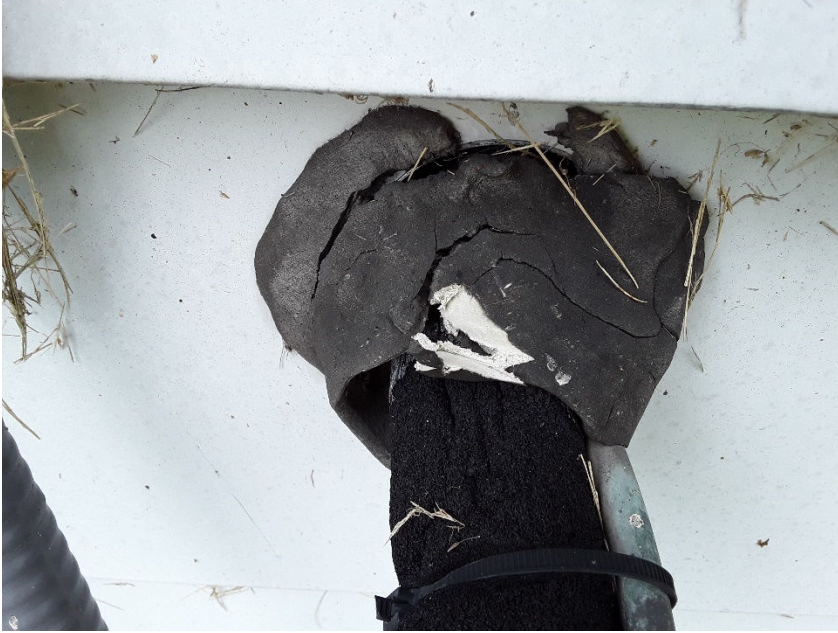
### **Photograph 17**

View of Light Grey Exterior Pipe Penetration  
Caulk  
(HA16)

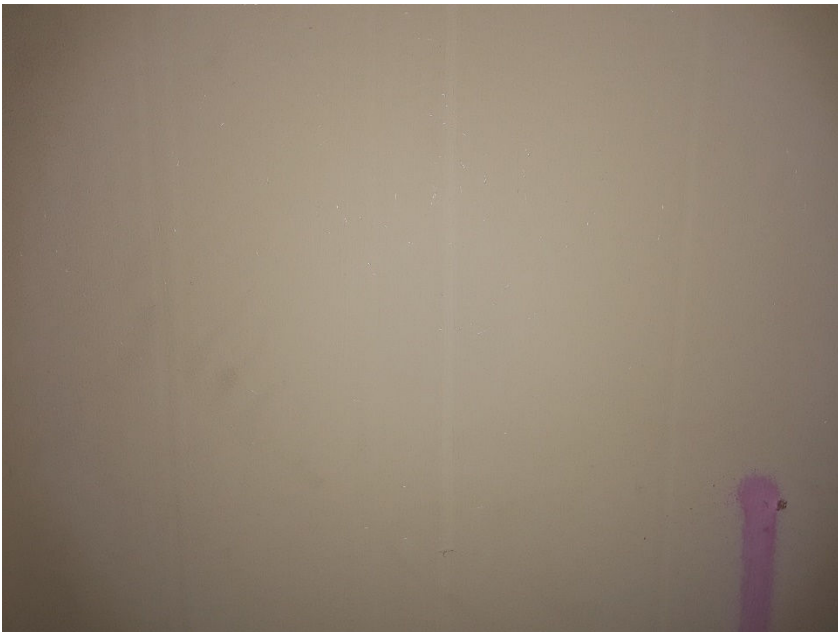
### **Photograph 18**

Typical View of Beige Interior Paint on Wood  
Panels  
(PC-1)

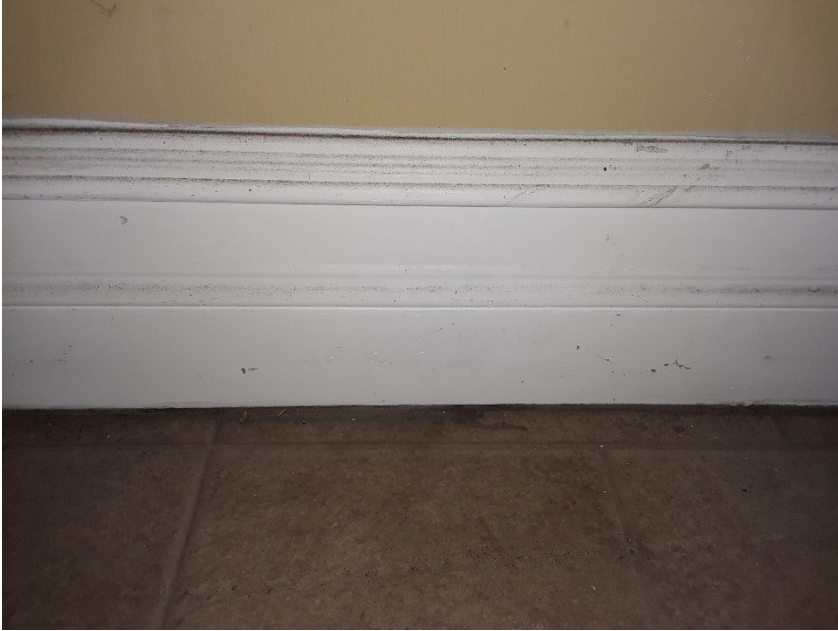
### Photograph 19

Typical View of White Interior Paint on Wood  
(PC-2)

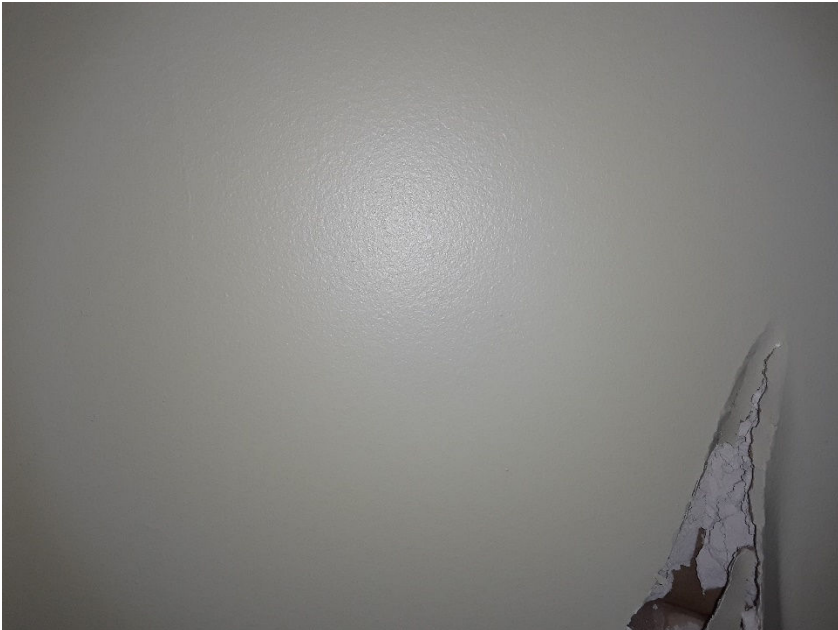
### Photograph 20

Typical View of Light Green Interior Paint on  
Drywall  
(PC-3)

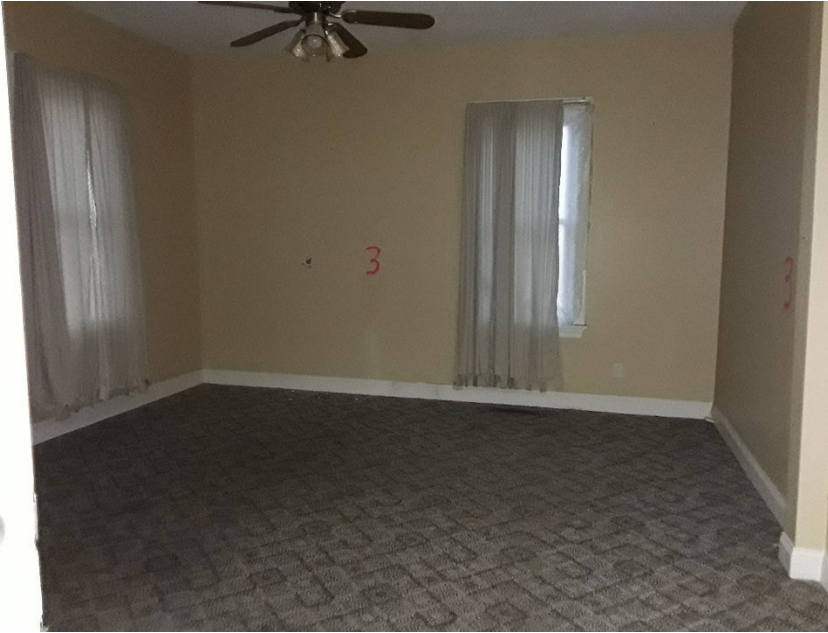
### Photograph 21

Typical View of Beige Interior Paint on Drywall  
(PC-4)

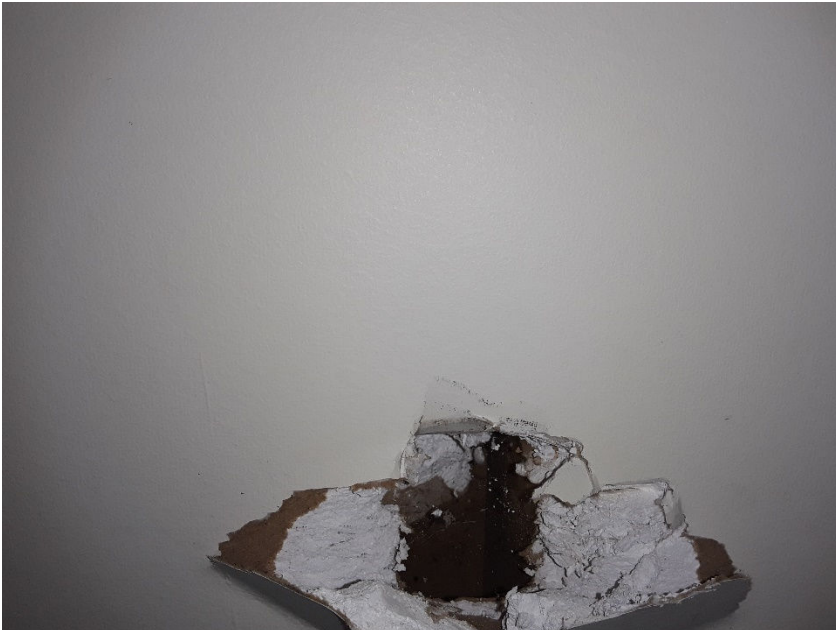
### Photograph 22

Typical View of Pale Yellow Interior Paint on  
Drywall  
(PC-5)

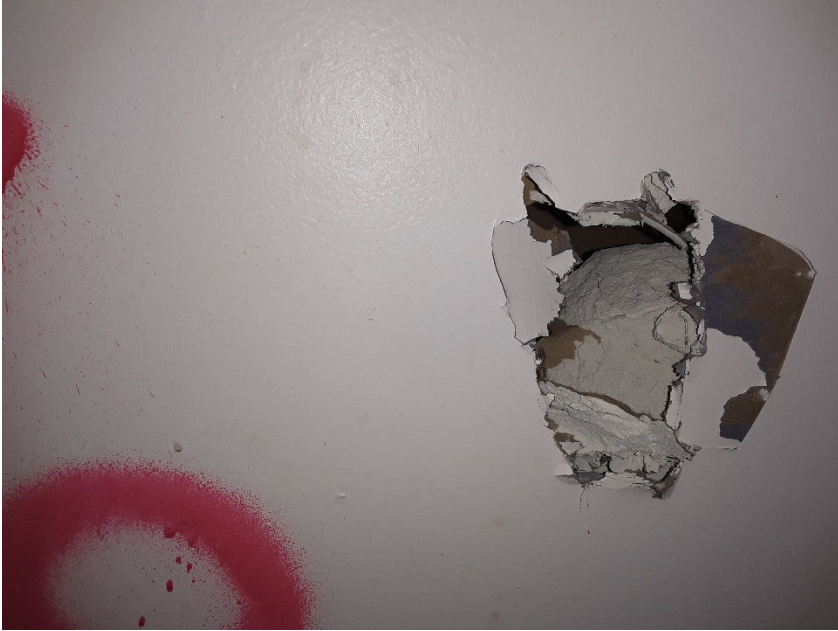
### Photograph 23

Typical View of Pale Purple Interior Paint on  
Drywall  
(PC-6)

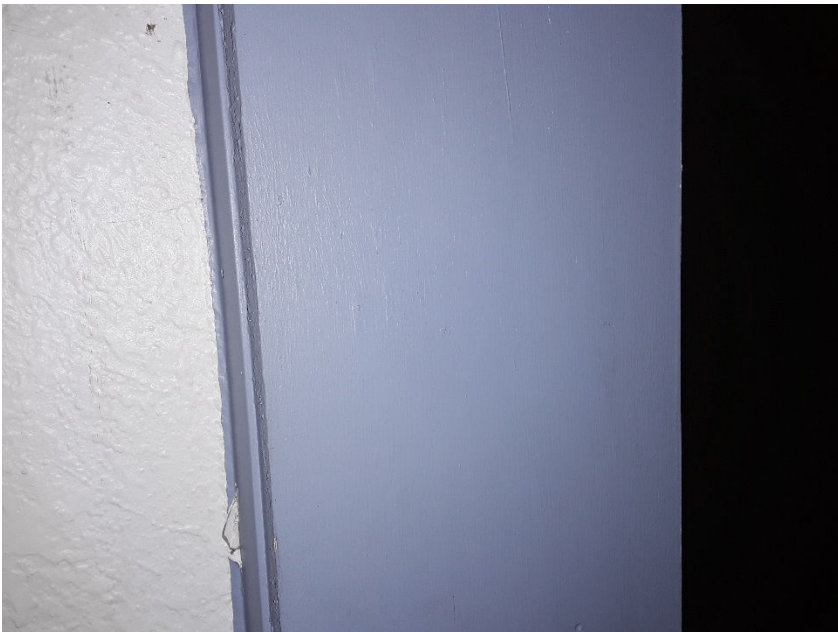
### Photograph 24

Typical View of Blue Interior Paint on Wood  
(PC-7)

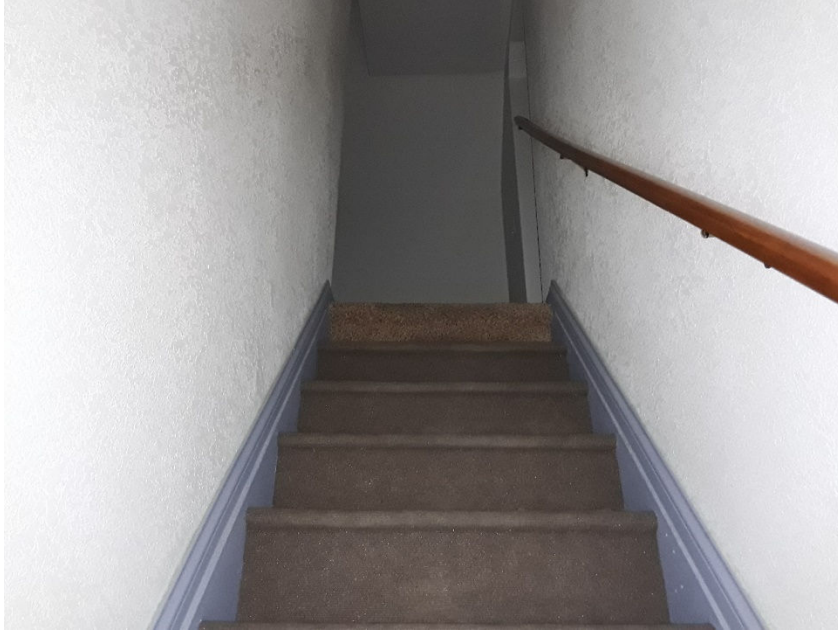
### **Photograph 25**

Typical View of White Interior Paint on Drywall  
(PC-8)

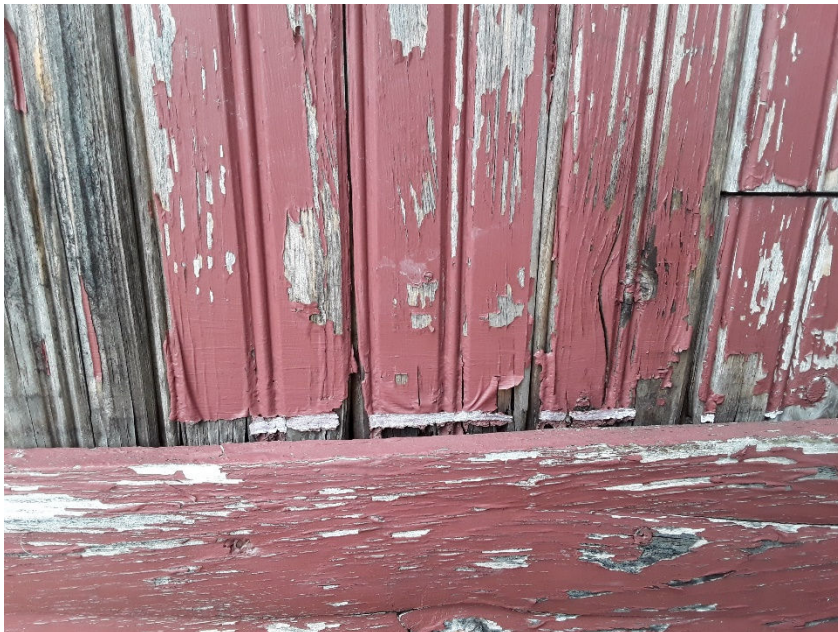
### **Photograph 26**

Typical View of Maroon Exterior Paint on Wood  
(PC-9)

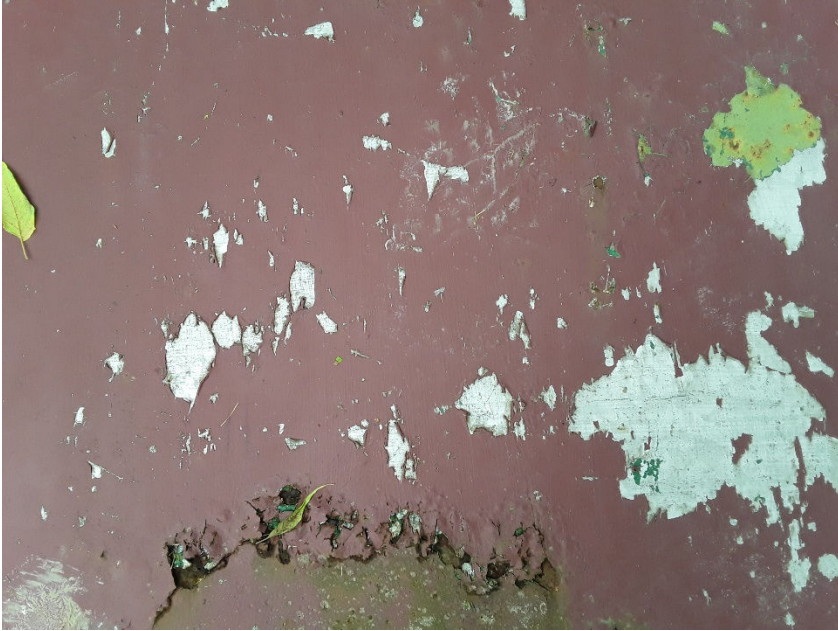
### **Photograph 27**

Typical View of Maroon Exterior Paint on Metal  
(PC-10)
