# Pre-Demolition Hazardous Materials Survey

Former YMCA Building  
111 North Madison Avenue  
Bay City, Michigan 48708

**PROJECT #** 11146s2-2-194

**DATE** November 9, 2017

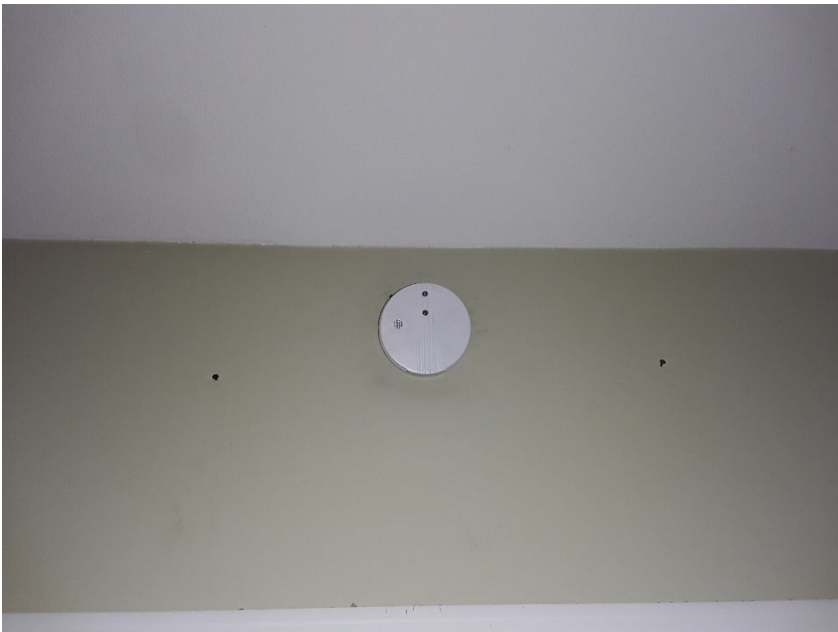
### **Photograph 28**

Typical View of a Smoke Detector

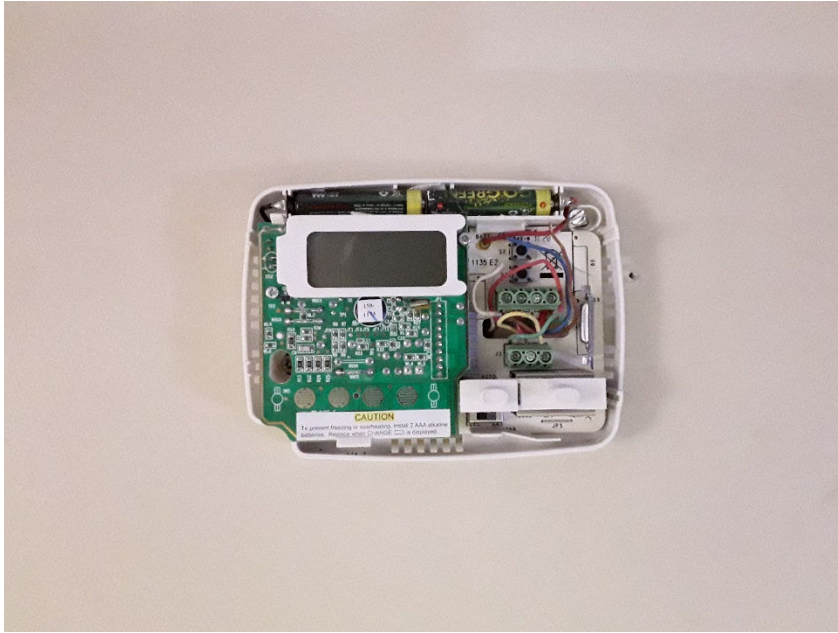
### Photograph 29

Typical View of a Thermostat

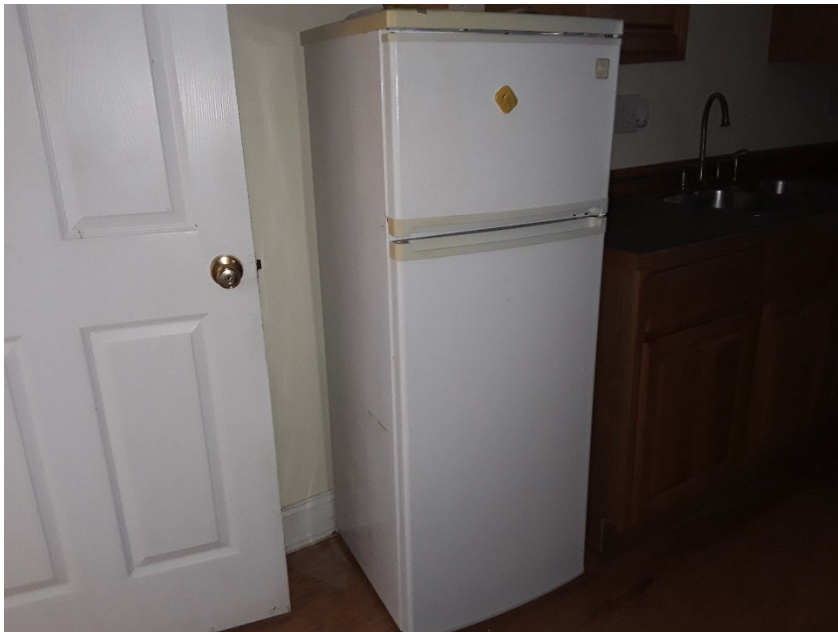
### Photograph 30

Typical View of a Refrigerator

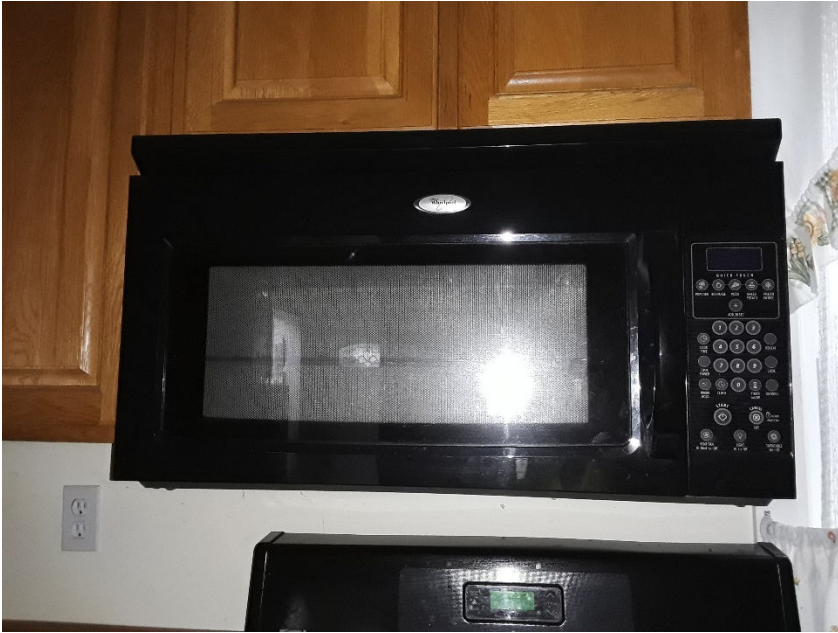
### Photograph 31

Typical View of a Microwave

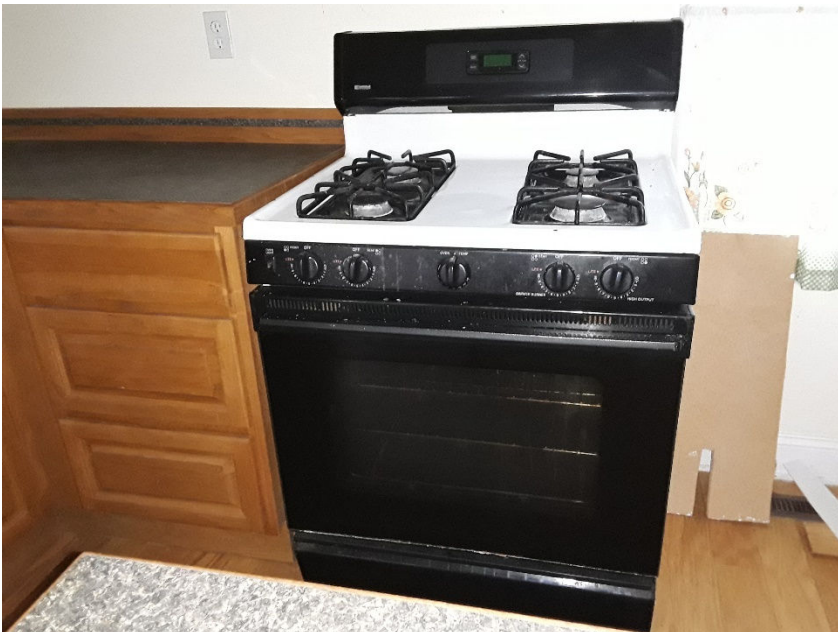
### Photograph 32

Typical View of an Oven

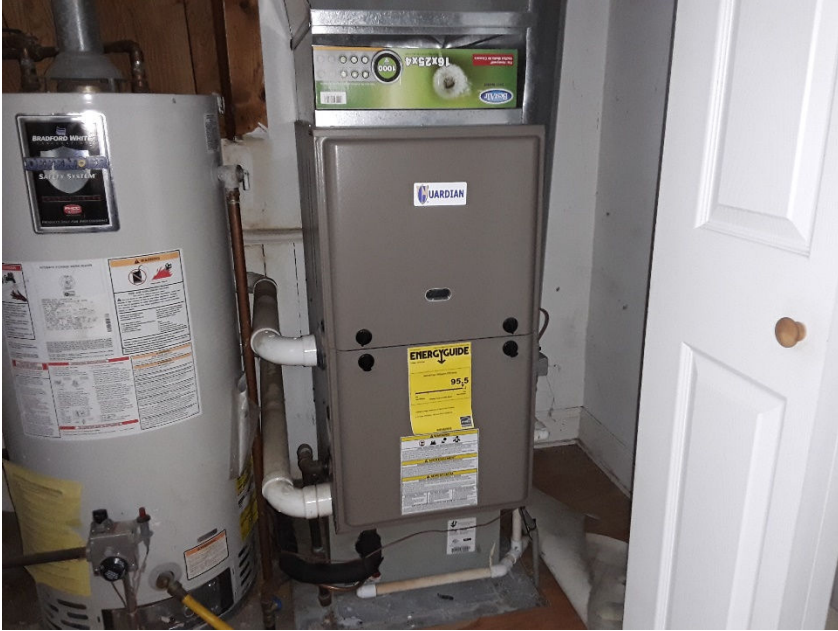
### Photograph 33

Typical View of a Furnace

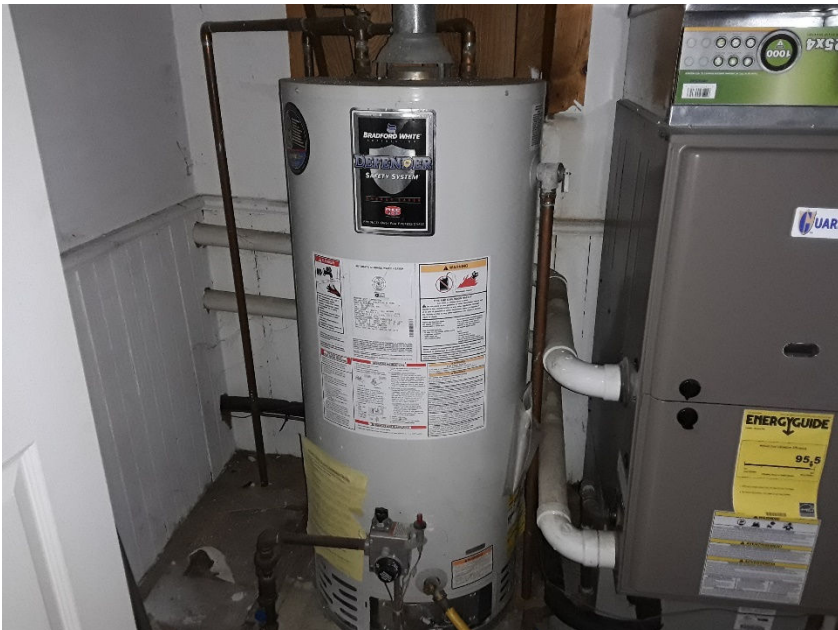
### Photograph 34

Typical View of a Water Heater

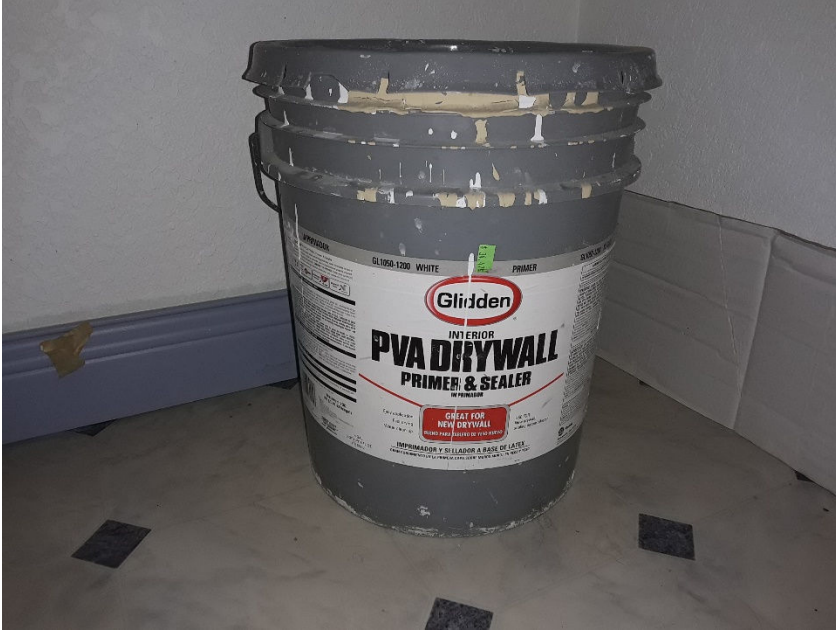
### Photograph 35

Typical View of Drywall Primer and Sealer

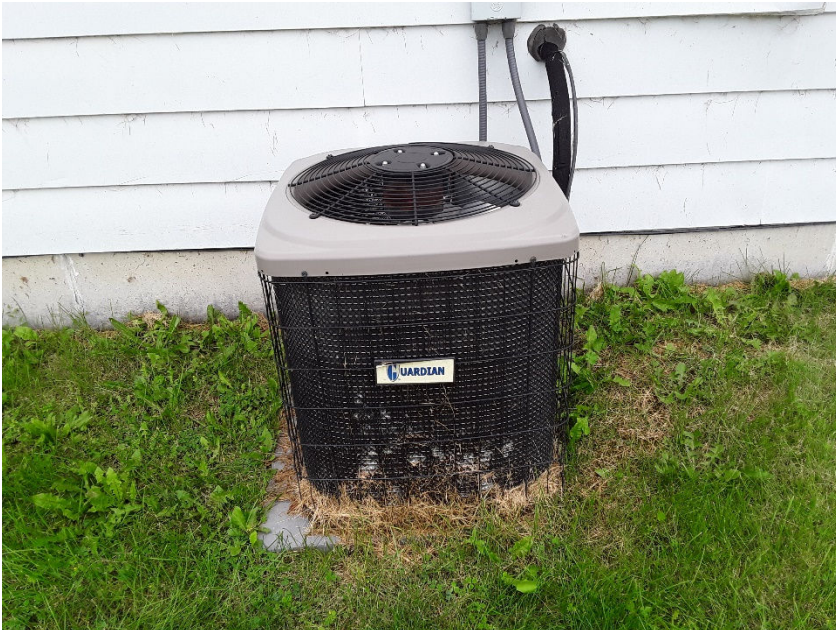
### Photograph 36

Typical View of an Air Conditioner
